DEXTER A. HOLADAY II
Marine Surveyor

PHOTO REPORT

Vessel: EDDIE MAXWELL 1988 28' Nauset Marine lobster style committee boat

Date of Inspection: 31 January 2024

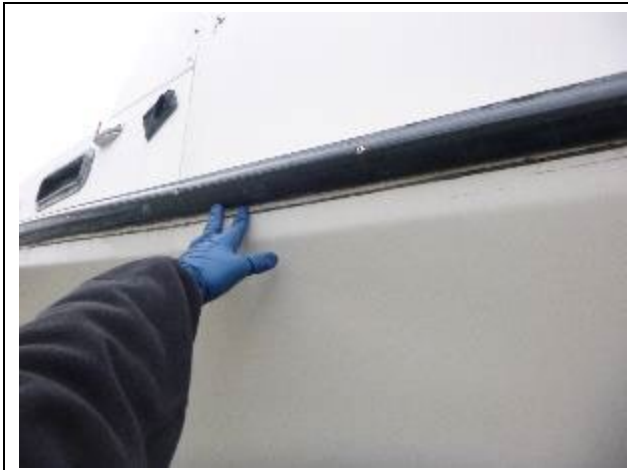
Port rubrail damaged and shifted.

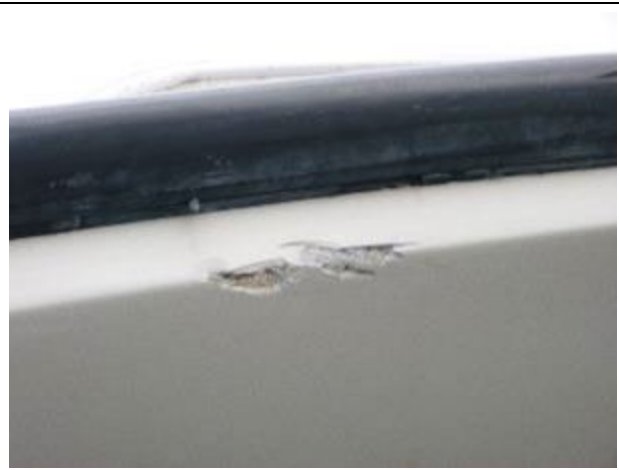
Numerous gelcoat gouges on the topsides.

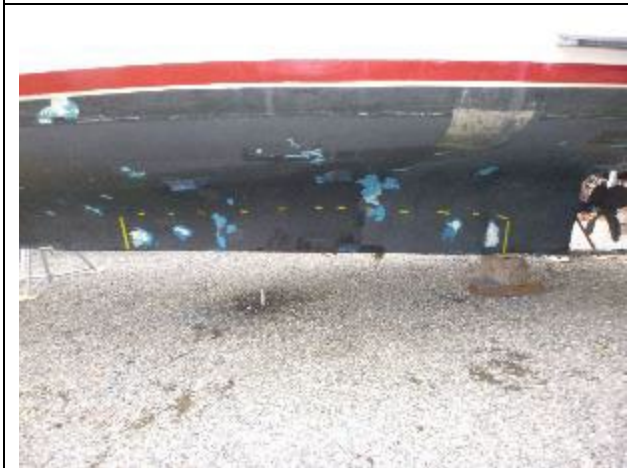
Yellow tape marking off area of gelcoat stress cracking the port amidships keel.

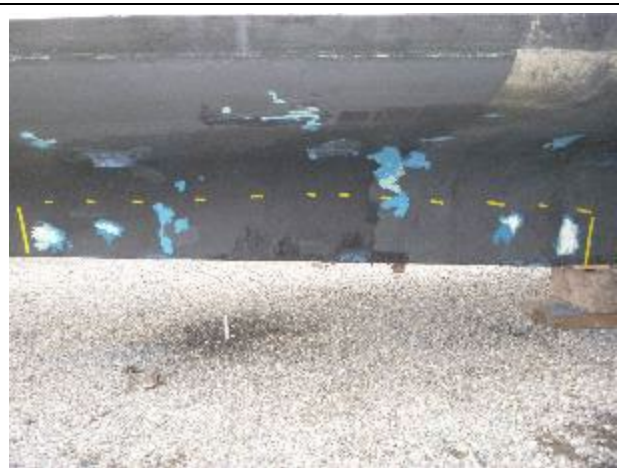
Yellow tape marking off area of gelcoat stress cracking the port amidships keel.

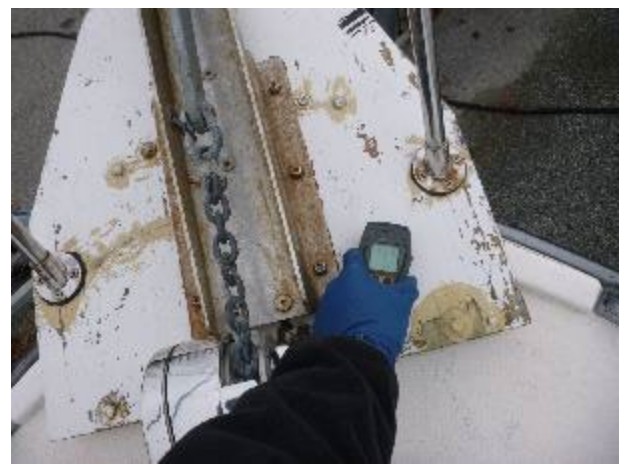
Maximum elevated moisture in the anchor pulpit. Meter reading 999.

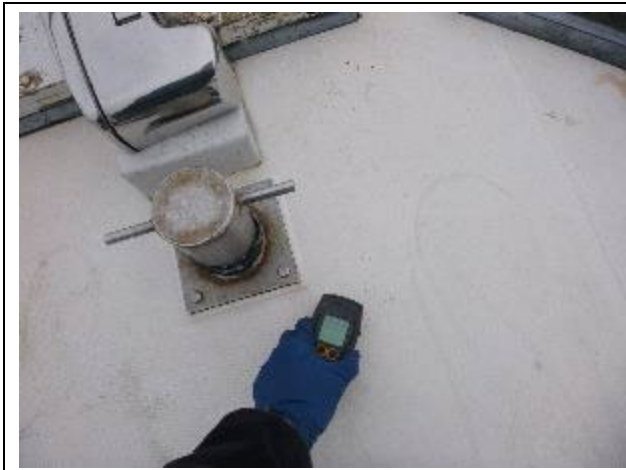
Elevated moisture in the foredeck. Meter reading 207.

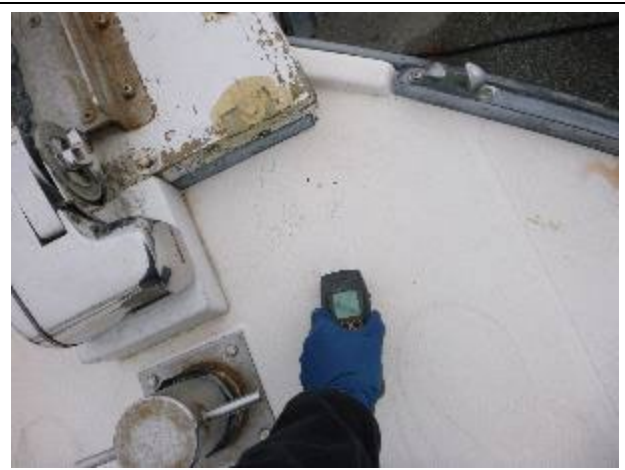
Elevated moisture in the foredeck. Meter reading 212.

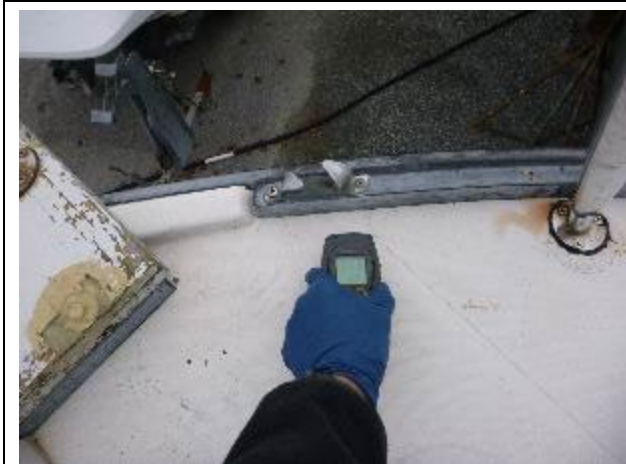
Elevated moisture in the foredeck. Meter reading 239.

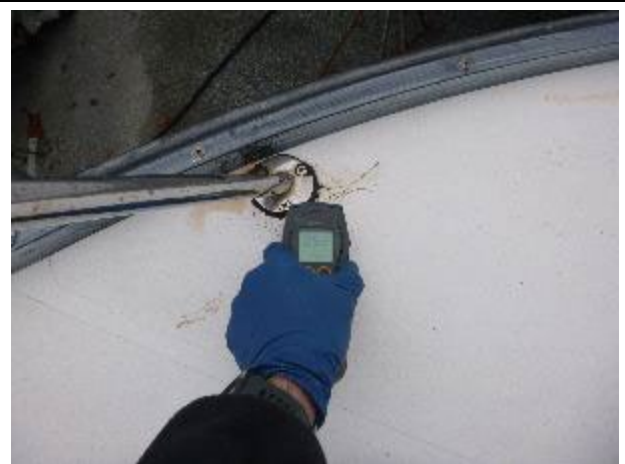
Elevated moisture in the foredeck. Meter reading 258.

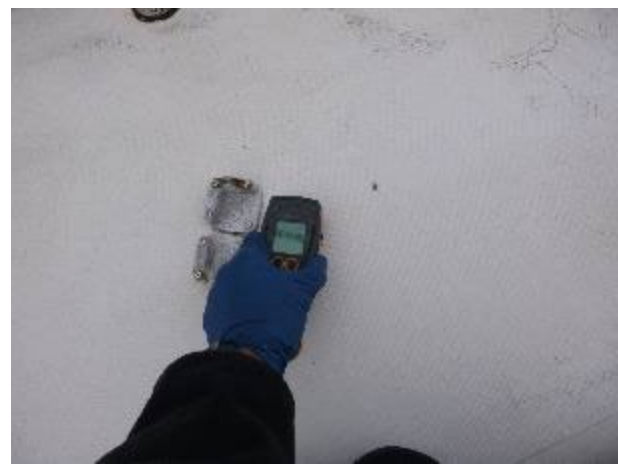
Elevated moisture in the foredeck. Meter reading 220.

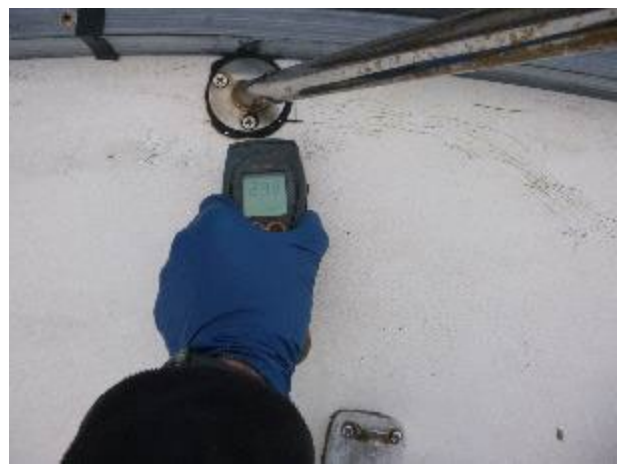
Elevated moisture in the foredeck. Meter reading 248.

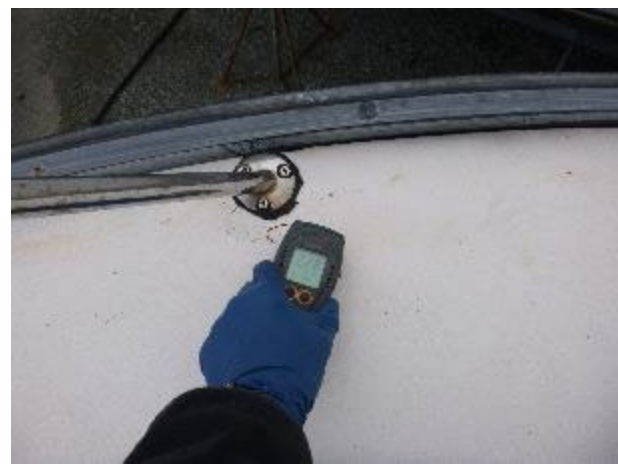
Elevated moisture in the foredeck. Meter reading 228.

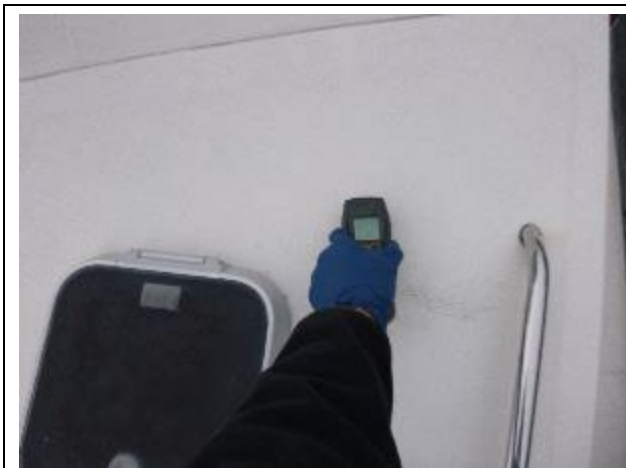
Elevated moisture in the port side top of the forward trunk cabin. Meter reading 215.

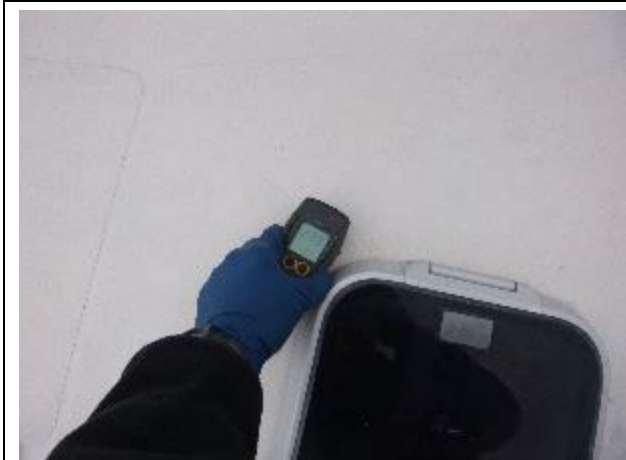
Elevated moisture in the forward trunk cabin deck. Meter reading 228.

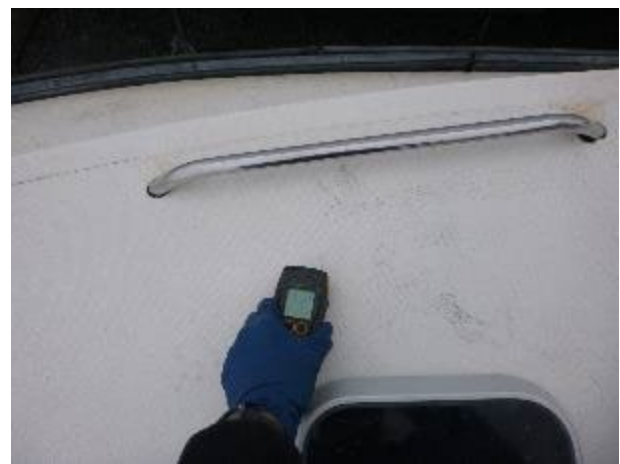
Elevated moisture in the starboard side of the forward trunk cabin. Meter reading 212.

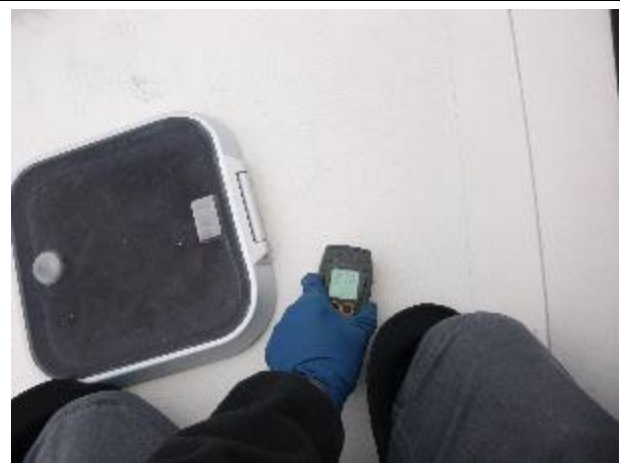
Elevated moisture in the starboard side of the forward trunk cabin. Meter reading 210.

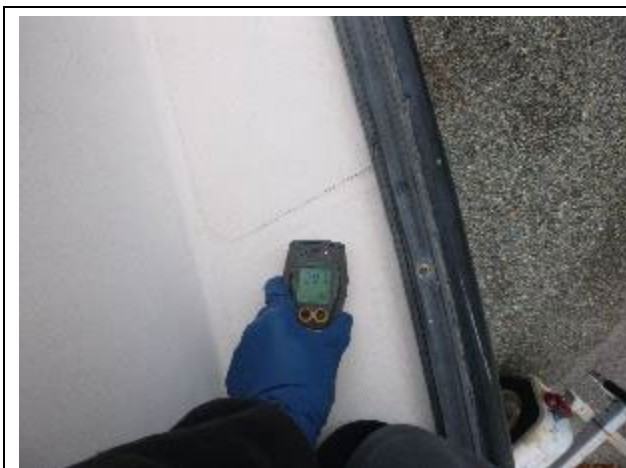
**Elevated moisture in the port side deck.
Meter reading 207.**

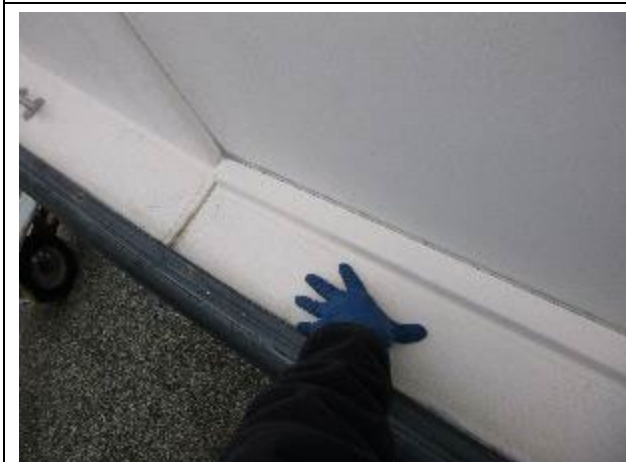
Delamination noted in the port side deck.

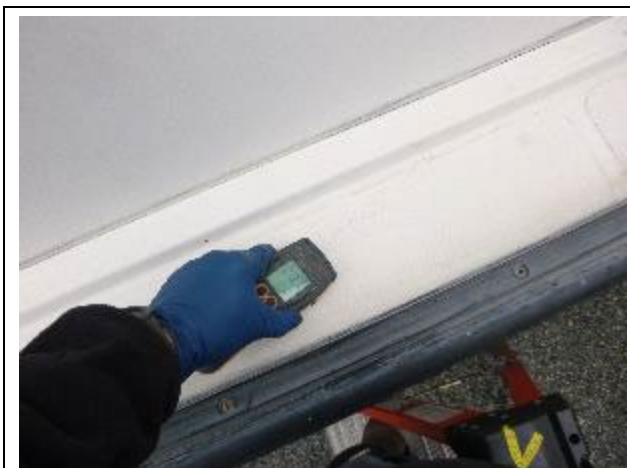
**Elevated moisture in the port side deck.
Meter reading 207.**

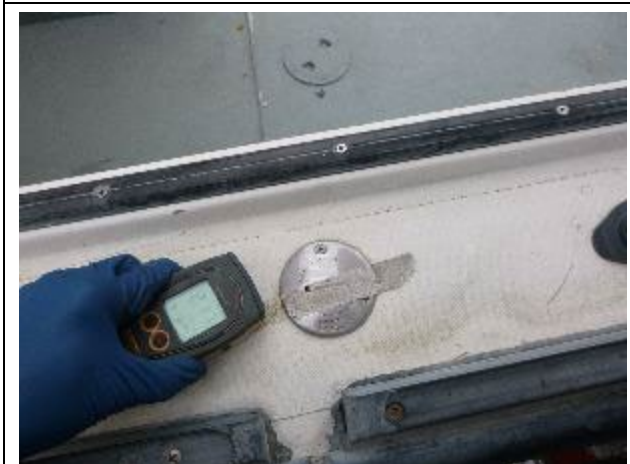
**Elevated moisture in the port coaming top.
Meter reading 217.**

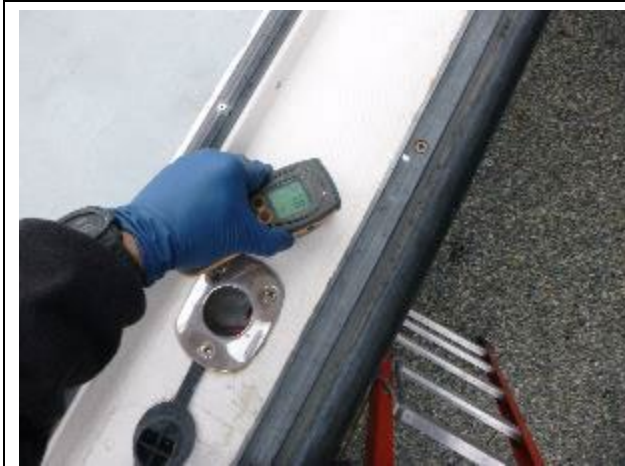
**Elevated moisture in the port coaming top.
Meter reading 218.**

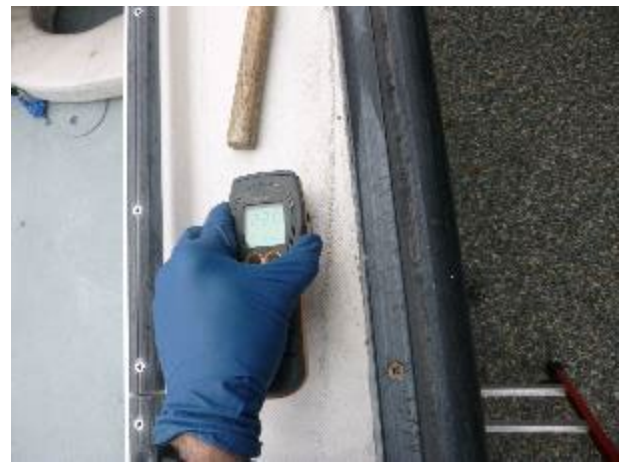
**Elevated moisture in the port coaming top.
Meter reading 220.**

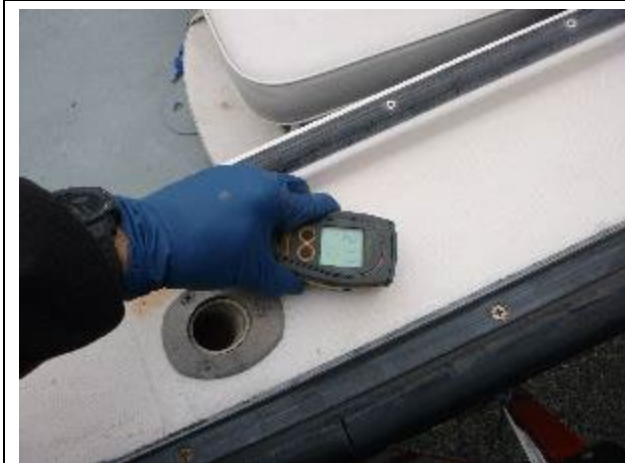
**Elevated moisture in the port coaming top.
Meter reading 217.**

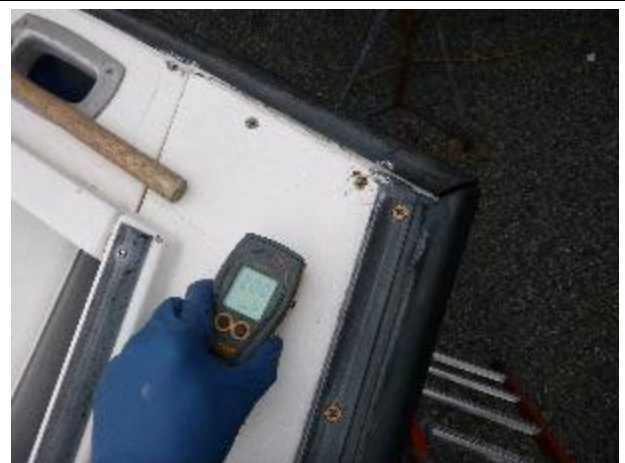
**Elevated moisture in the port coaming top.
Meter reading 200.**

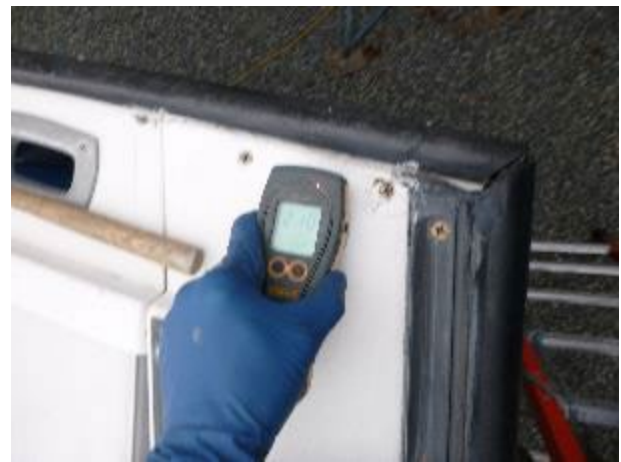
Elevated moisture in the aft end of the port coaming top. Meter reading 210.

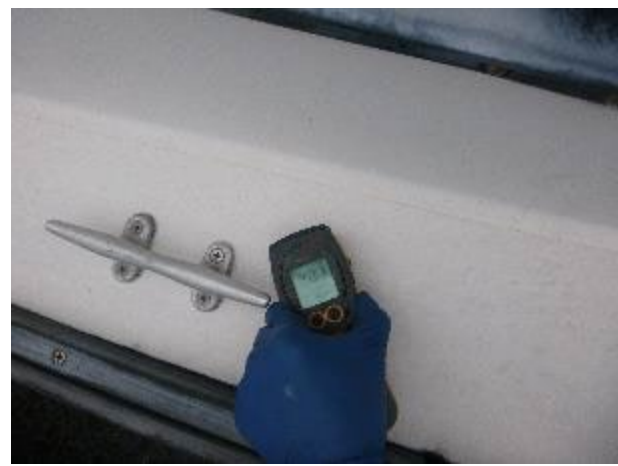
**Elevated moisture in the starboard side deck.
Meter reading 207.**

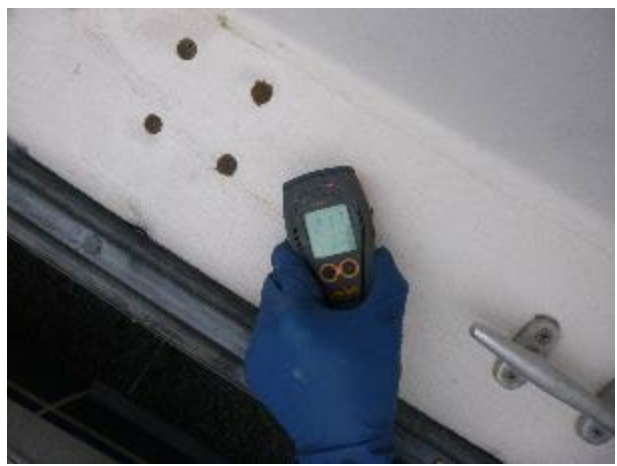
**Elevated moisture in the starboard side deck.
Meter reading 217.**

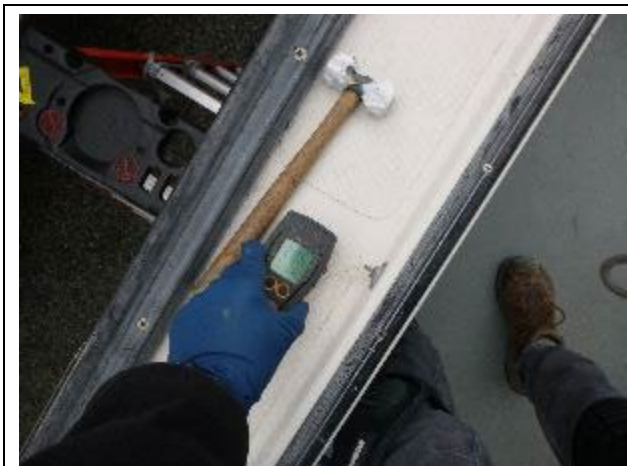
Elevated moisture in the starboard coaming top. Meter reading 215.

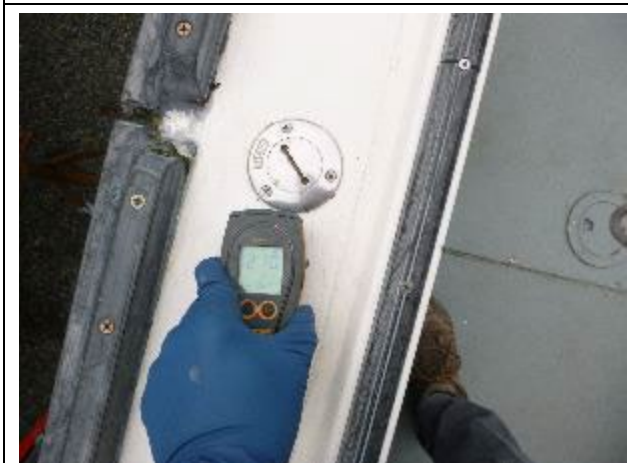
Elevated moisture in the starboard coaming top. Meter reading 210.

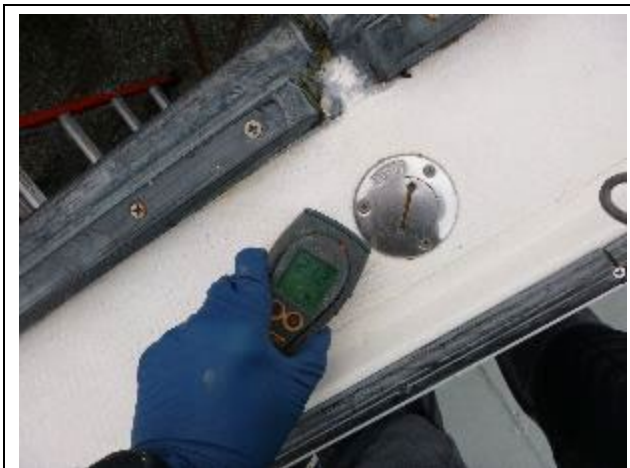
Elevated moisture in the starboard coaming top. Meter reading 212.

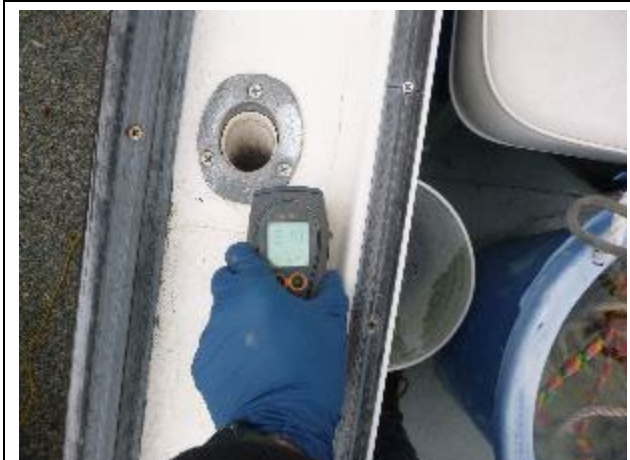
Elevated moisture in the starboard coaming top. Meter reading 210.

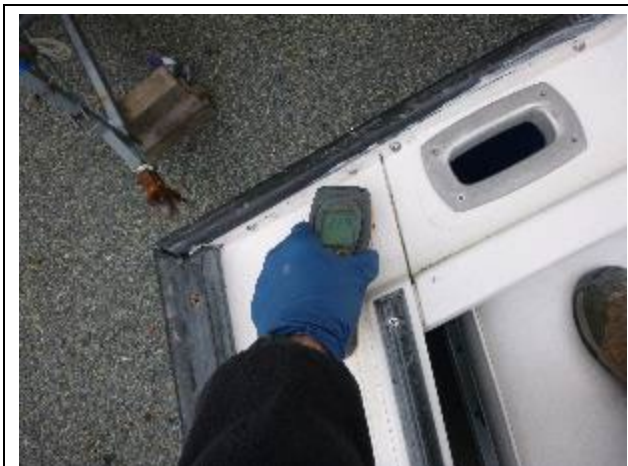
Elevated moisture in the starboard aft coaming top. Meter reading 229.

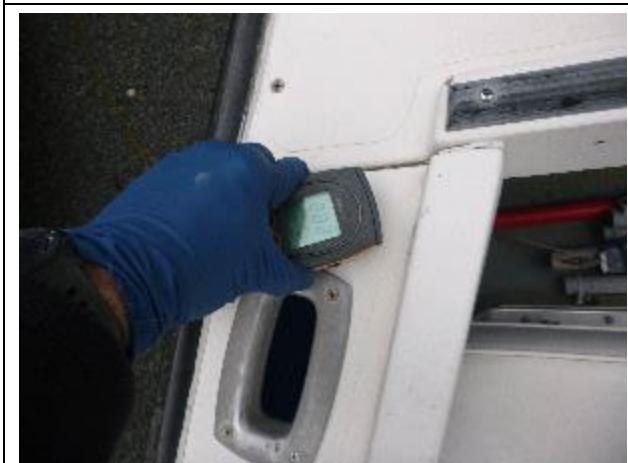
Elevated moisture in the starboard aft coaming top. Meter reading 202.

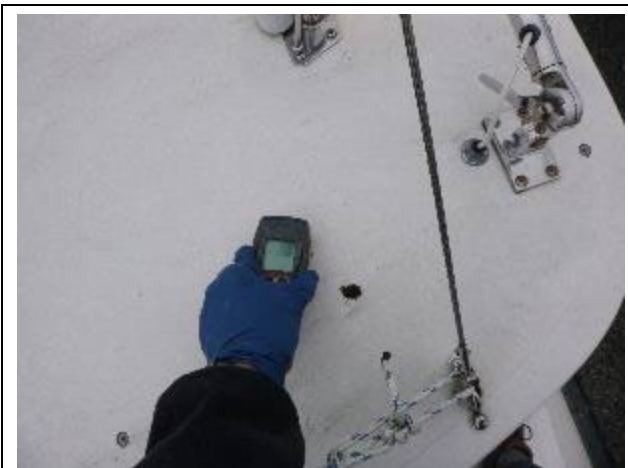
Elevated moisture in the hardtop, starboard forward. Meter reading 220.

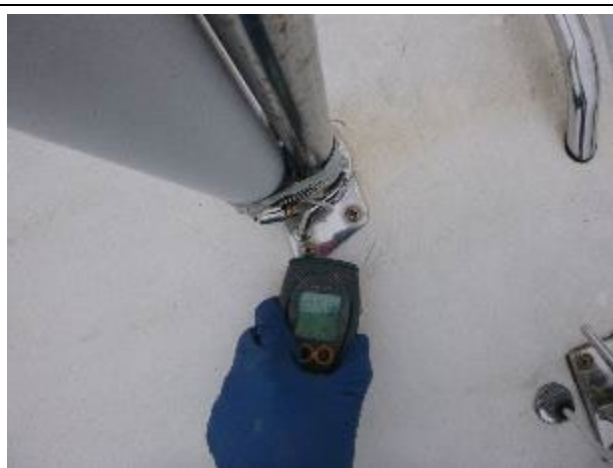
Elevated moisture in the hardtop, starboard forward. Meter reading 258.

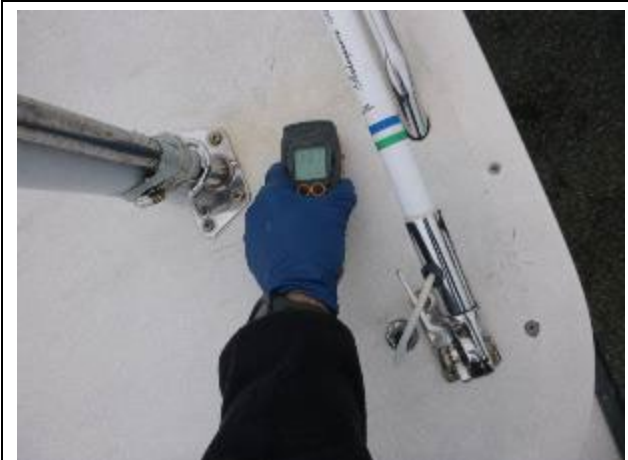
Elevated moisture in the hardtop, starboard forward. Meter reading 207.

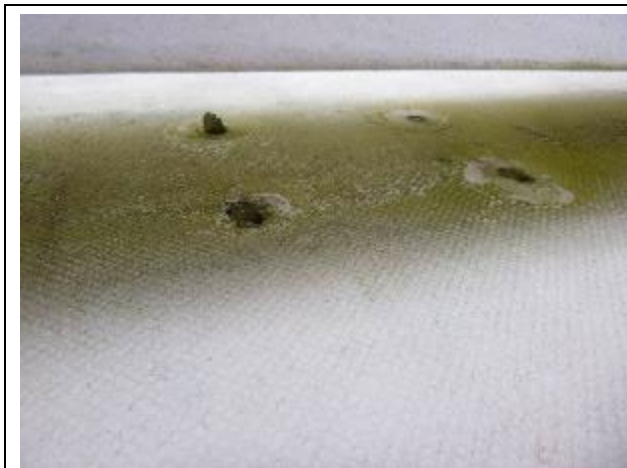
Poorly filled old fastener holes in the hardtop below the course board structure.

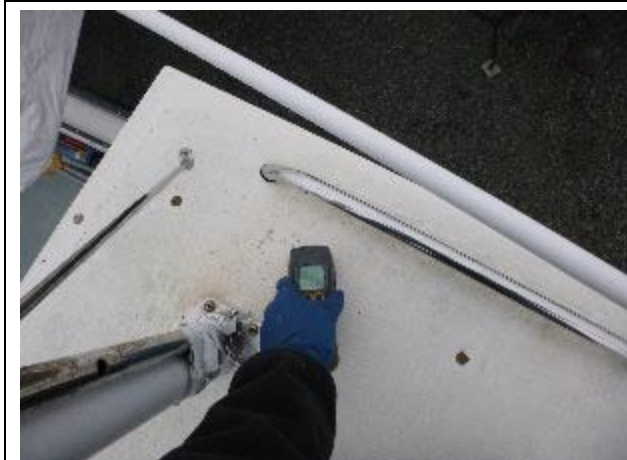
Elevated moisture in the hardtop, aft. Meter reading 210.

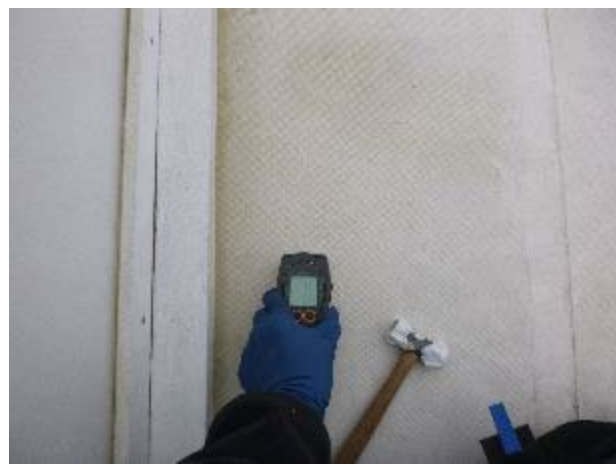
**Elevated moisture in the hardtop middle.
Meter reading 215.**

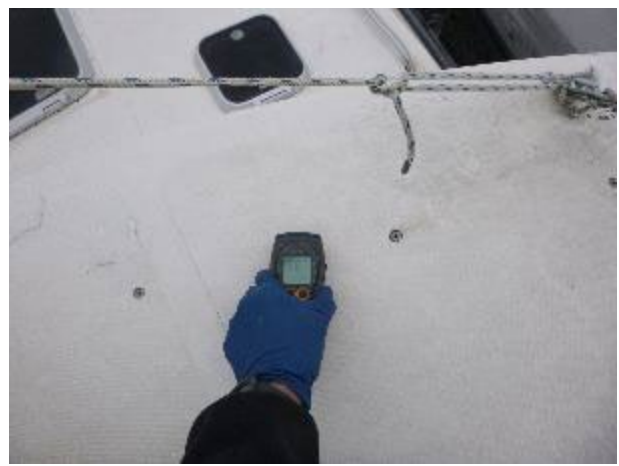
**Elevated moisture in the hardtop. Meter
reading 207.**

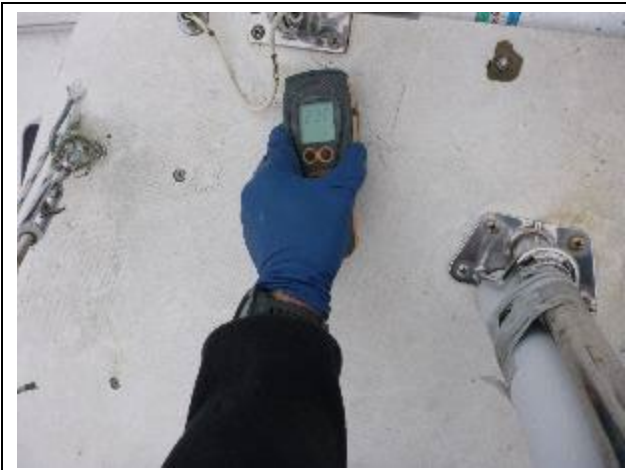
Elevated moisture in the hardtop to starboard. Meter reading 220.

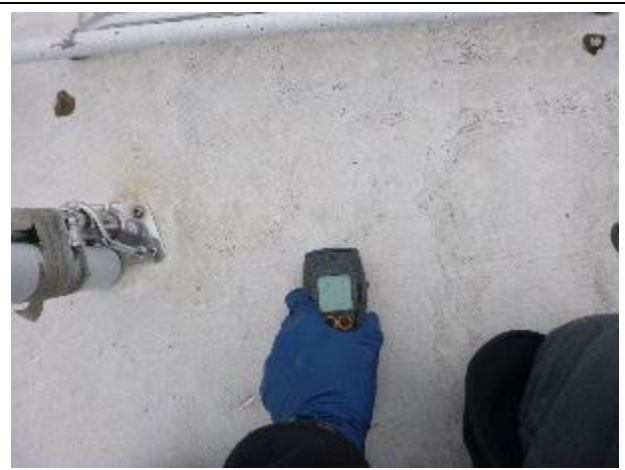
Elevated moisture in the hardtop to starboard. Meter reading 215.

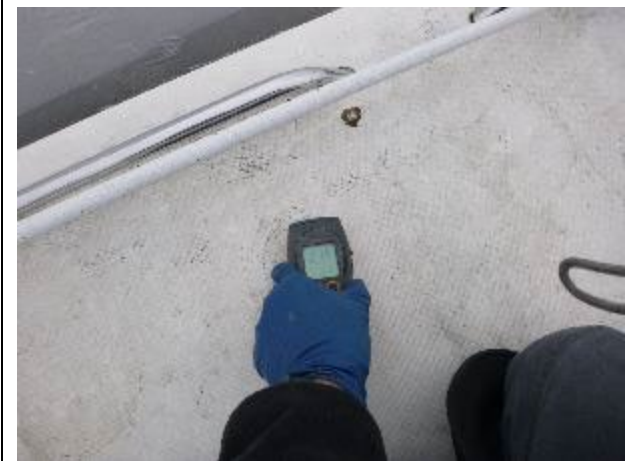
Elevated moisture in the hardtop to starboard. Meter reading 215.

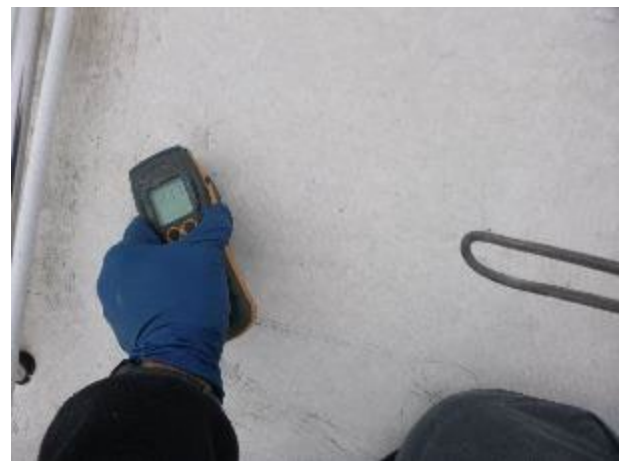
Elevated moisture in the hardtop to starboard. Meter reading 217.

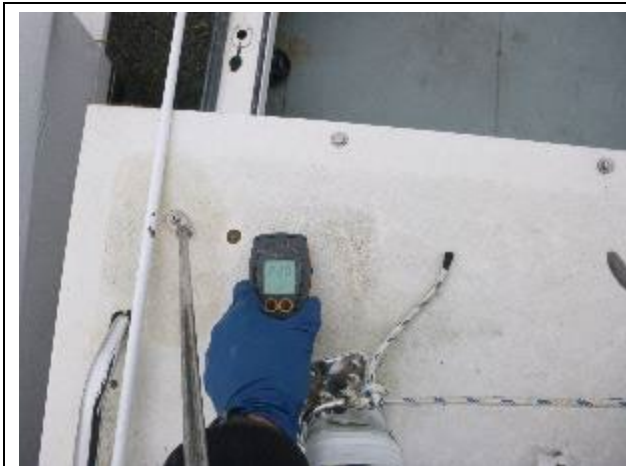
Elevated moisture in the hardtop, starboard aft. Meter reading 220.

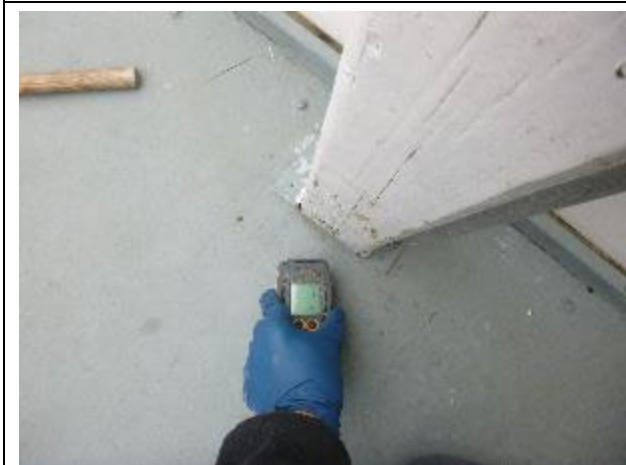
Elevated moisture in the cabinsole, forward to starboard. Meter reading 217.

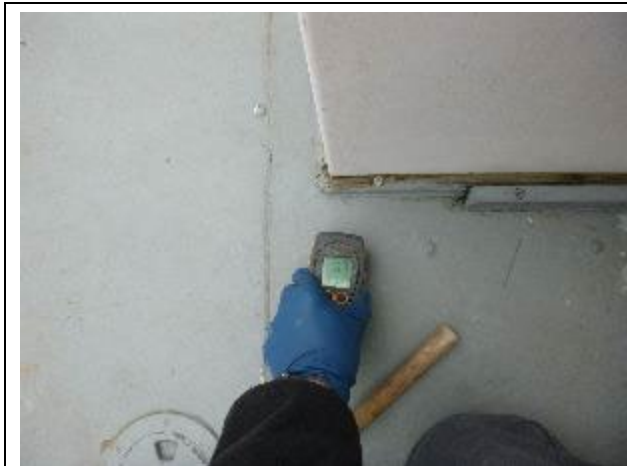
Elevated moisture in the cockpit sole to starboard of the engine box. Meter reading 207.

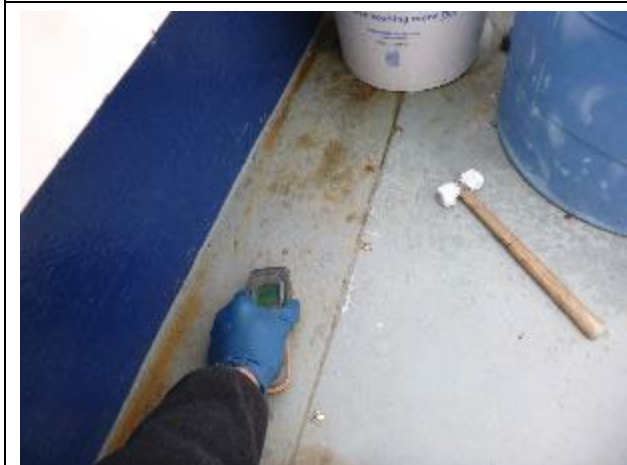
Elevated moisture in the cockpit sole to starboard. Meter reading 220.

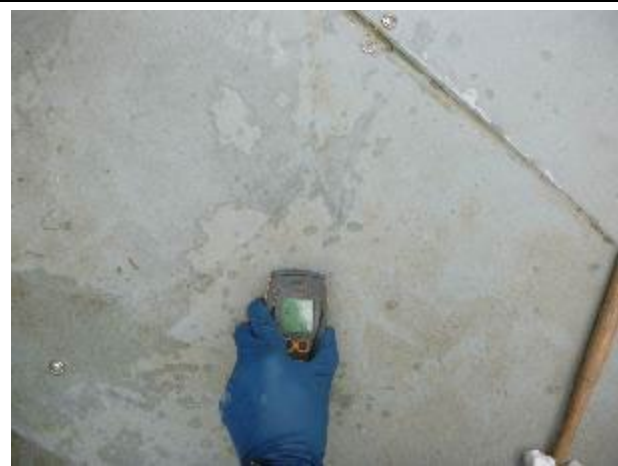
**Elevated moisture in the aft cockpit sole.
Meter reading 217.**

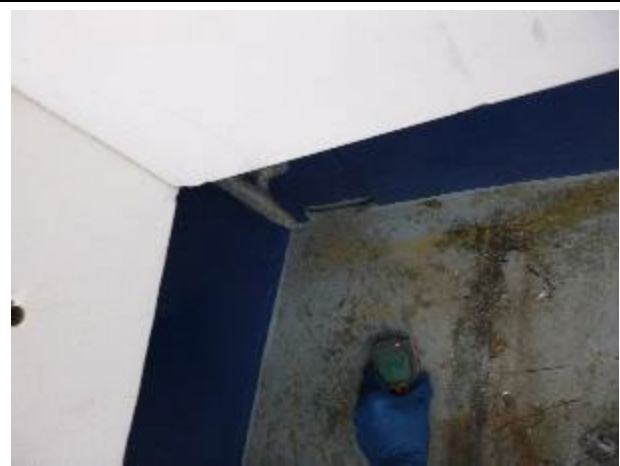
**Elevated moisture in the aft cockpit sole.
Meter reading 248.**

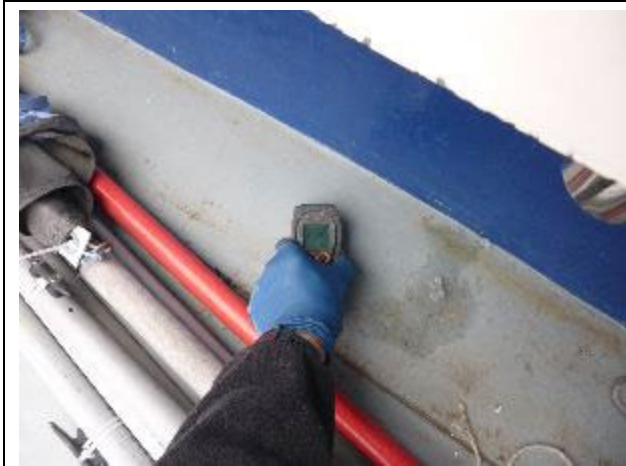
**Elevated moisture in the cockpit sole to port.
Meter reading 212.**

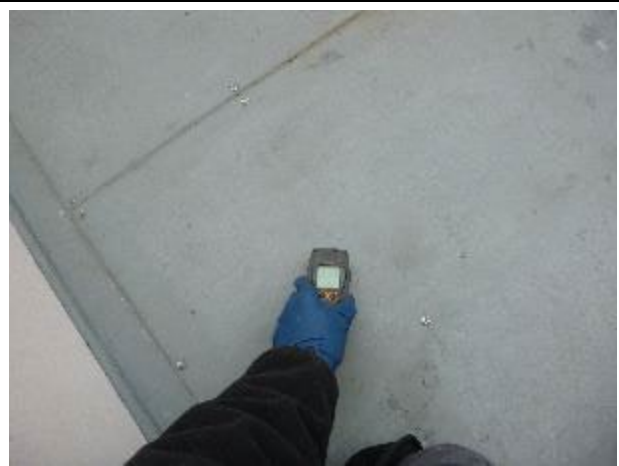
**Elevated moisture in the cockpit sole to port.
Meter reading 217.**

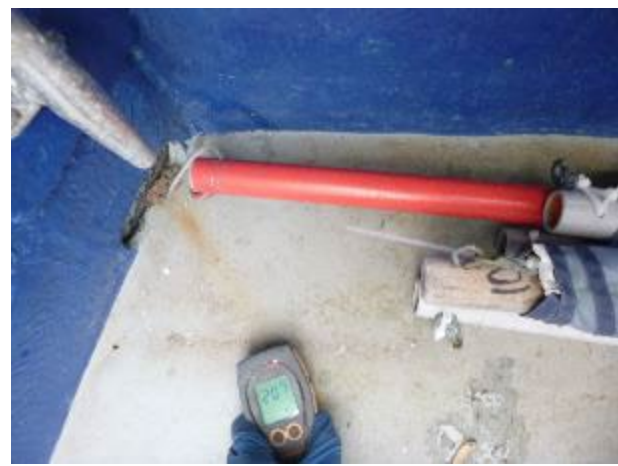
Elevated moisture in the cockpit sole aft to port. Meter reading 207.

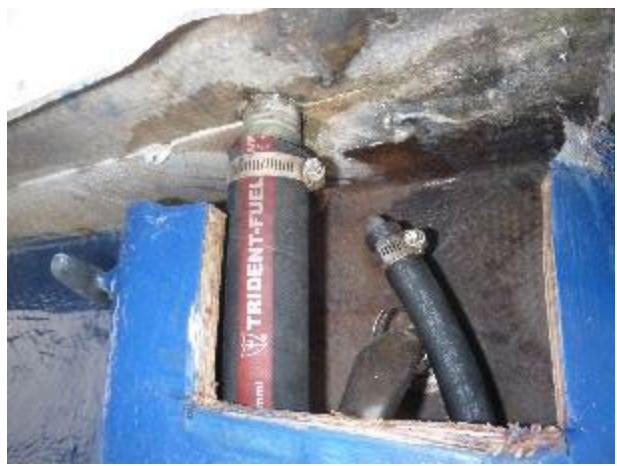
The fuel fill hose is not double hose clamped and is also loose on the deck fill spud. The fuel vent fitting is loose in the hull.

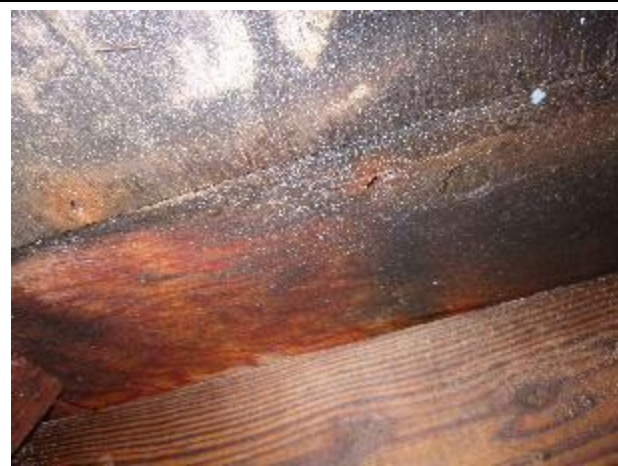
Cockpit sole plywood wet and starting to deteriorate aft.

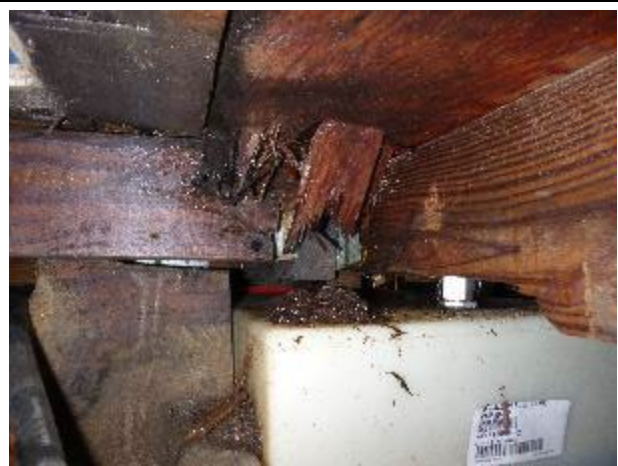
Cockpit sole plywood and structure deteriorated and wet aft of the starboard fuel tank.

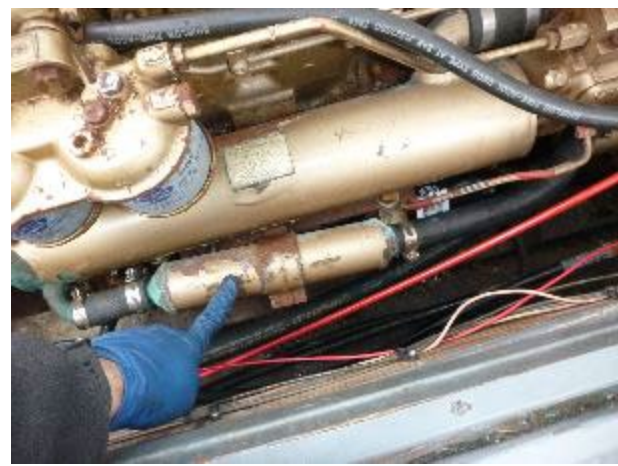
Rust and corrosion at the oil cooler to starboard.

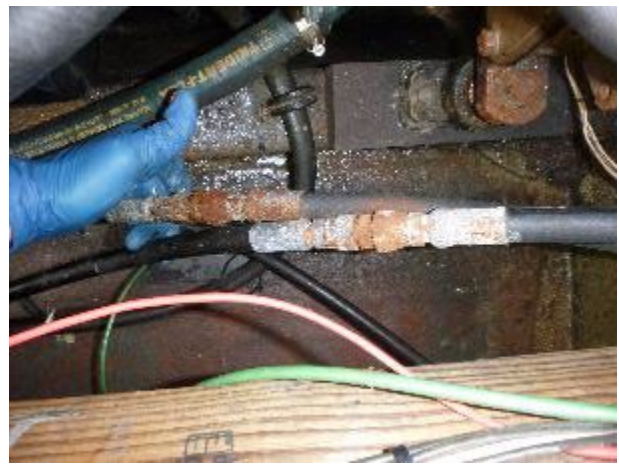
Steering hose connections rusted to starboard of the engine.

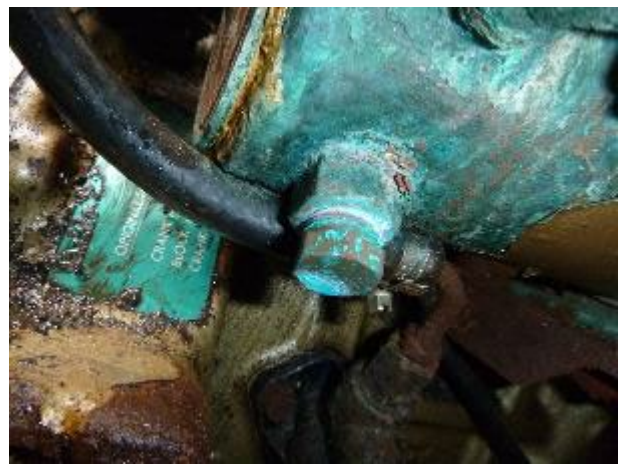
Engine heat exchanger corrosion.

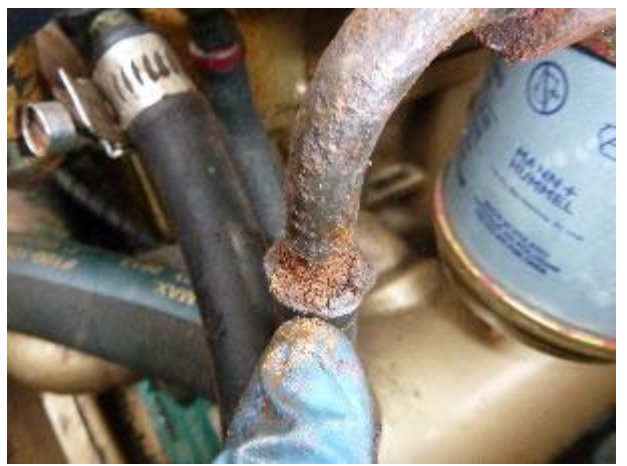
Closeup of the previous photo.

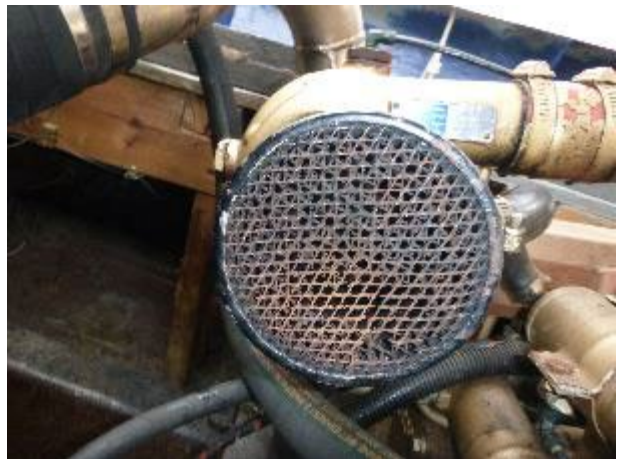
Air intake screen rusted through.

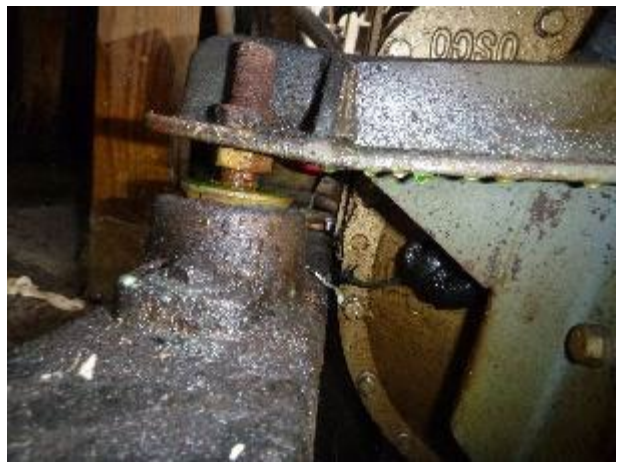
Antifreeze dripping of the port aft engine mount from a turbo leak.

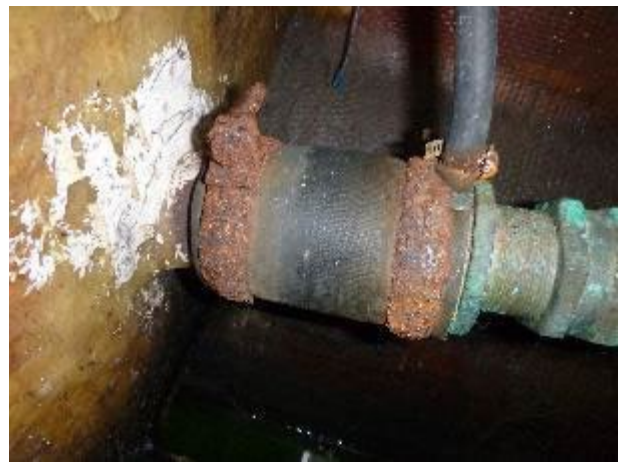
The stuffing box hose clamps are rusted, and the water injection hose clamp is broken.

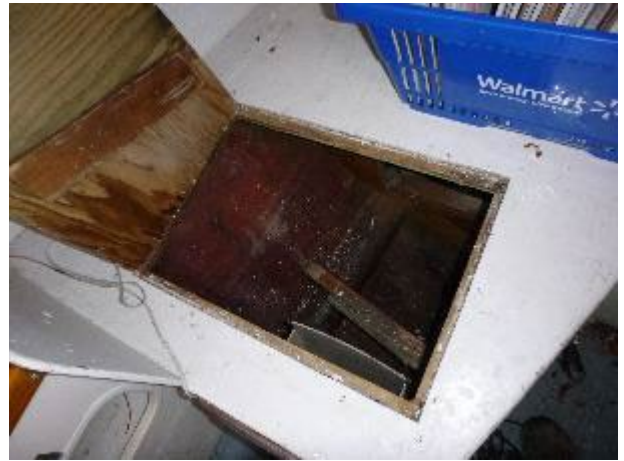
Wet vee berth plywood.
