DEXTER A. HOLADAY II
Marine Surveyor

PHOTO REPORT

Vessel: EDDIE MAXWELL 1988 28' Nauset Marine lobster style committee boat

Date of Inspection: 31 January 2024

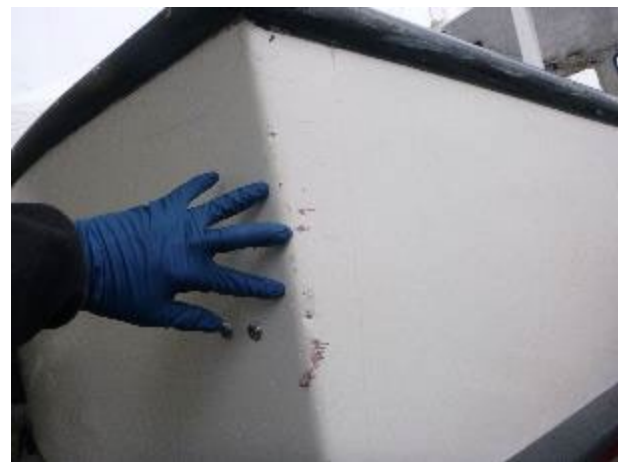
Transom corner damage.

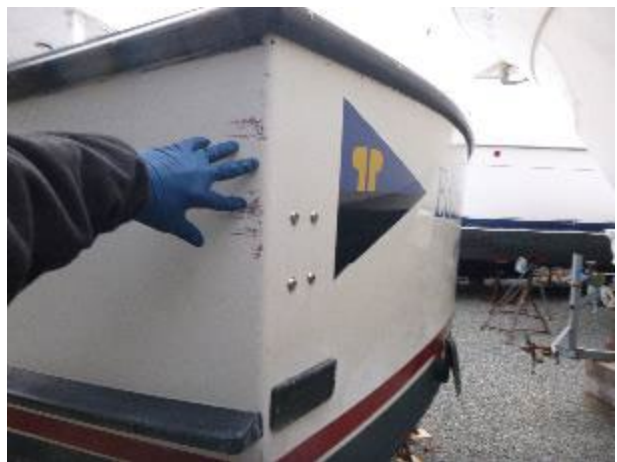
Transom corner damage.

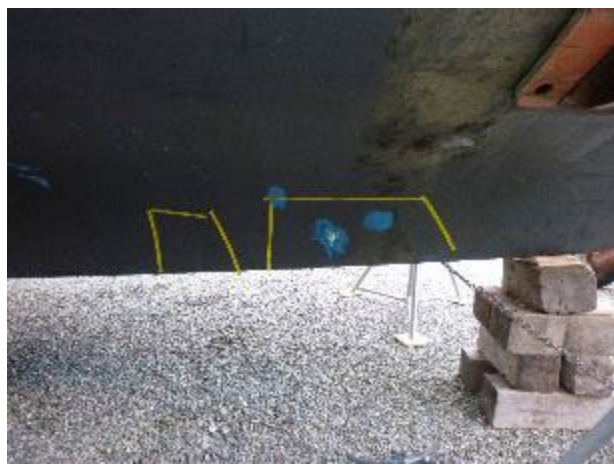
Yellow tape marking off areas of gelcoat stress cracking on the starboard keel.

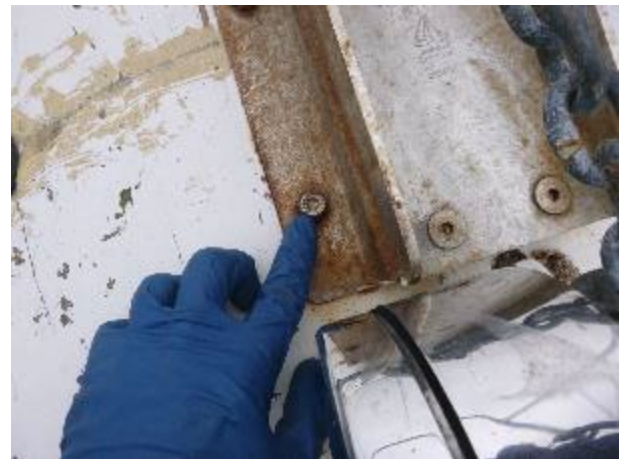
The anchor roller fasteners are not long enough to properly engage the nylon lock nuts.

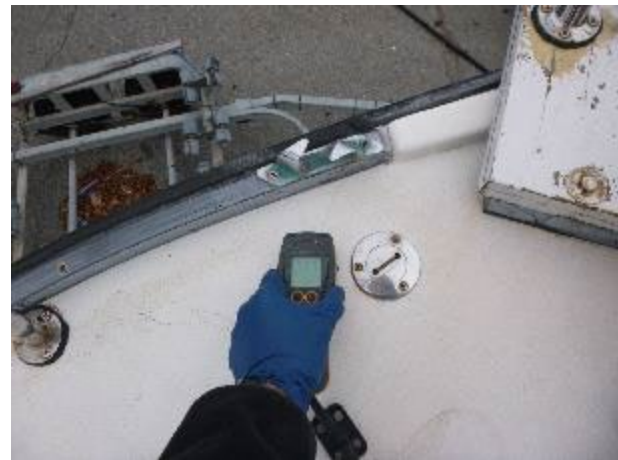
Elevated moisture in the foredeck. Meter reading 207.

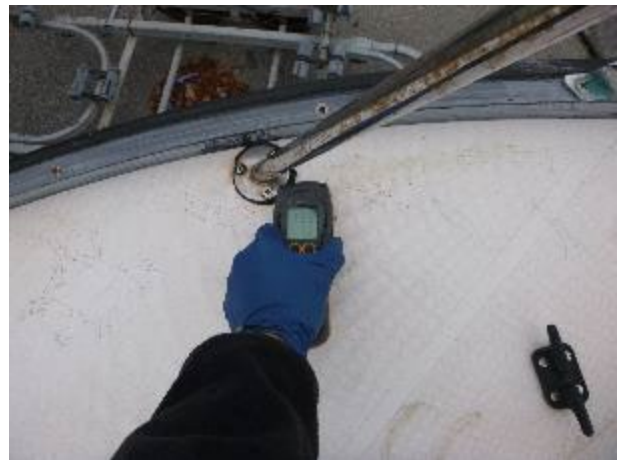
Elevated moisture in the foredeck. Meter reading 258.

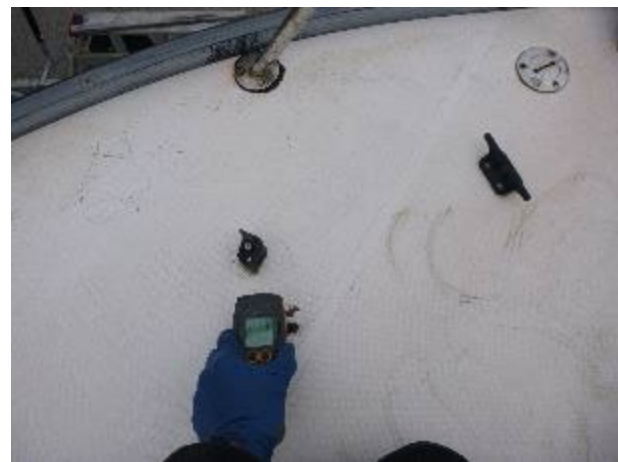
Elevated moisture in the foredeck. Meter reading 239.

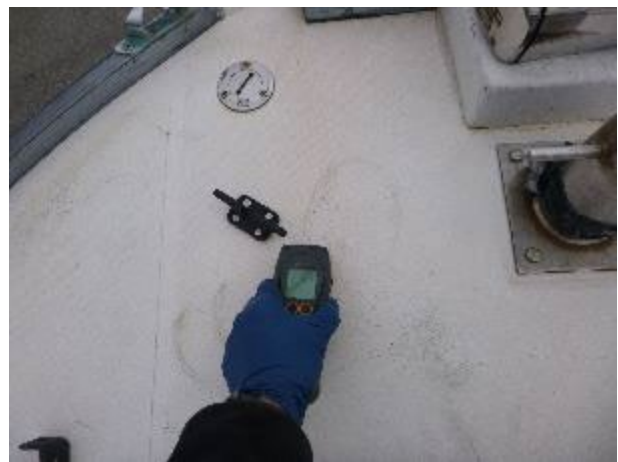
Elevated moisture in the foredeck. Meter reading 239.

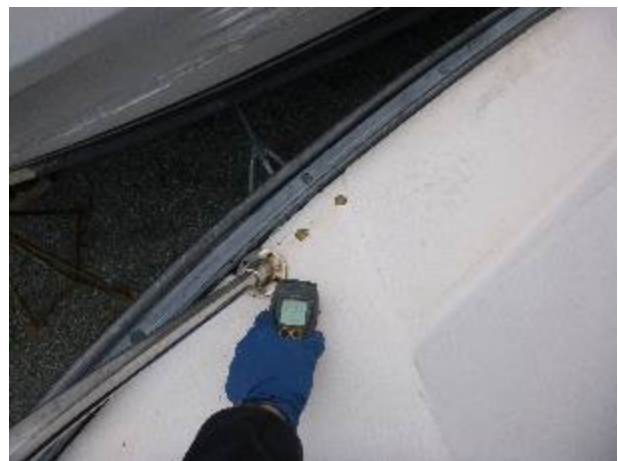
Elevated moisture in the foredeck. Meter reading 298.

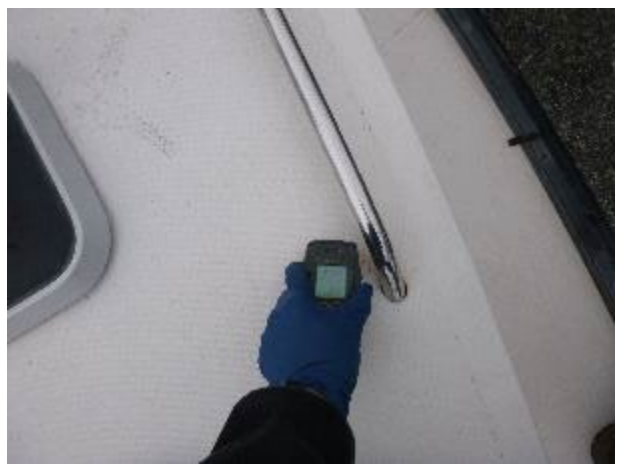
Elevated moisture in the port side top of the forward trunk cabin. Meter reading 220.

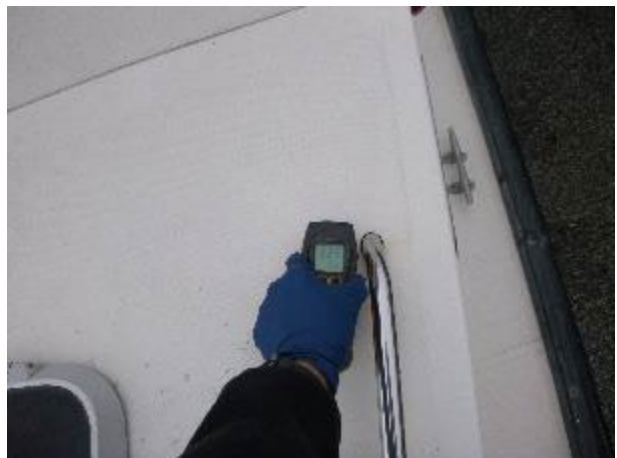
Elevated moisture in the port side top of the forward trunk cabin. Meter reading 229.

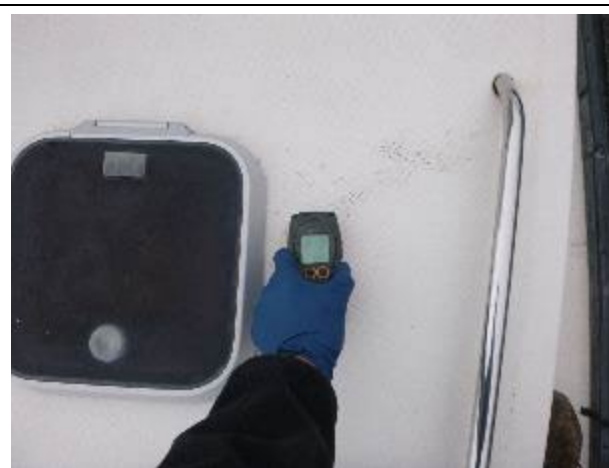
Elevated moisture in the port side top of the forward trunk cabin. Meter reading 212.

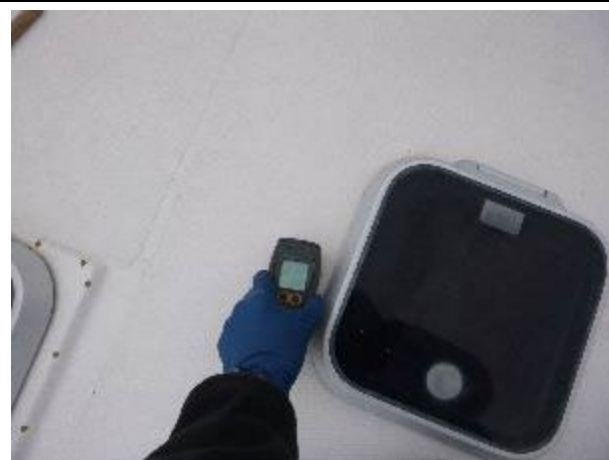
Elevated moisture in the forward trunk cabin deck. Meter reading 212.

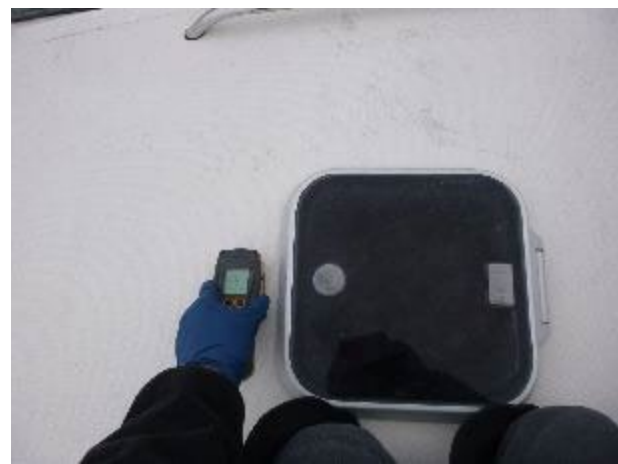
Elevated moisture in the starboard side of the forward trunk cabin. Meter reading 207.

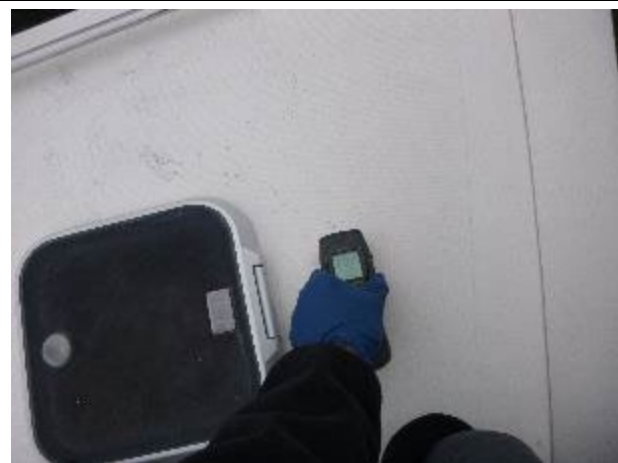
Elevated moisture in the starboard side of the forward trunk cabin. Meter reading 202.

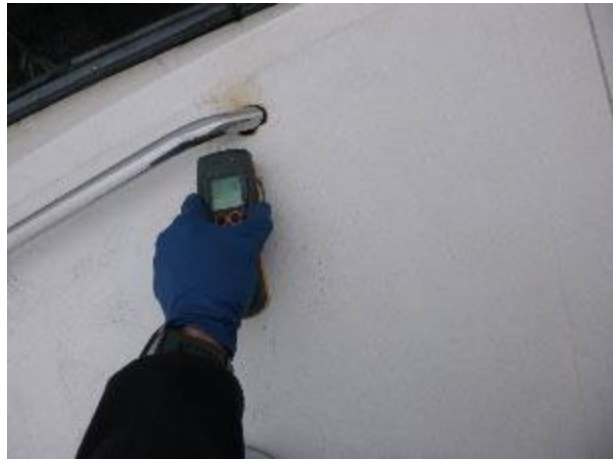
Elevated moisture in the starboard side of the forward trunk cabin. Meter reading 215.

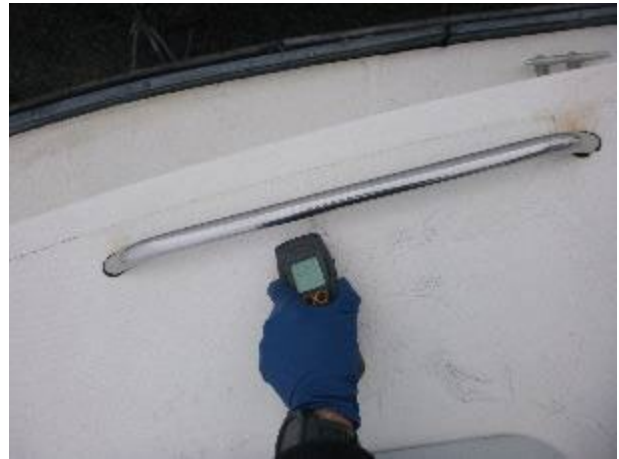
Elevated moisture in the starboard side of the forward trunk cabin. Meter reading 229.

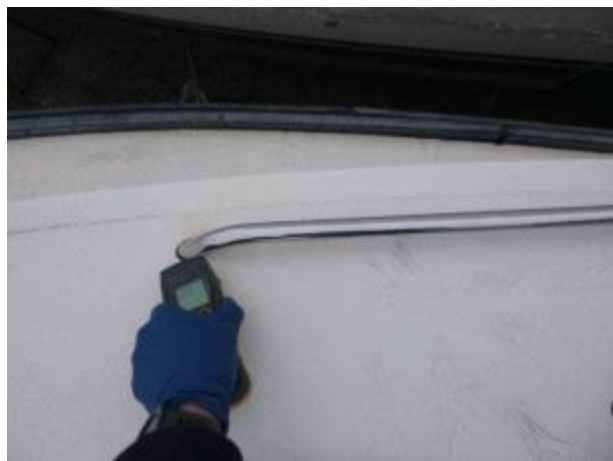
Elevated moisture in the starboard side of the forward trunk cabin. Meter reading 207.

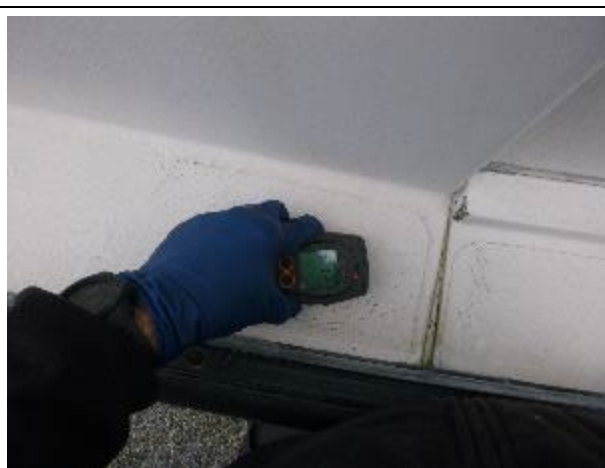
**Elevated moisture in the port side deck.
Meter reading 212.**

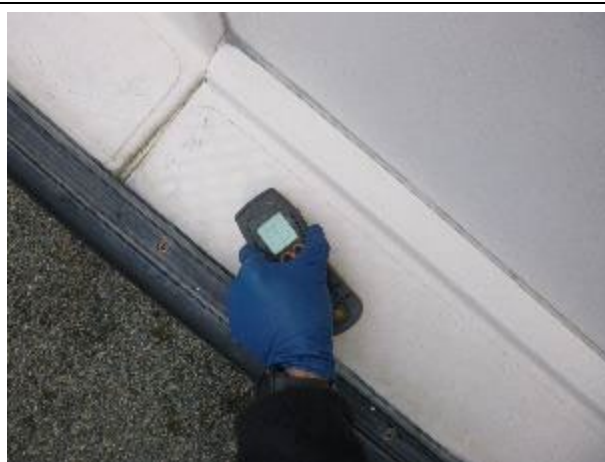
**Elevated moisture in the port side deck.
Meter reading 207.**

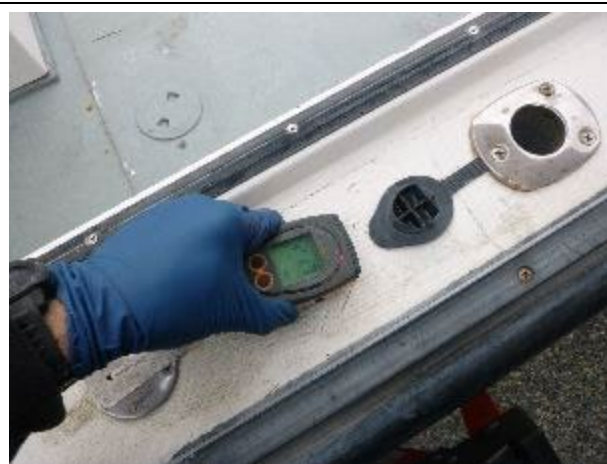
**Elevated moisture in the port coaming top.
Meter reading 217.**

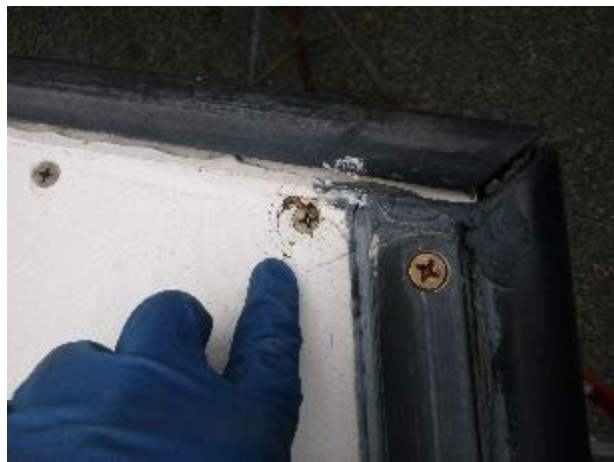
Pulled through transom coaming fastener.

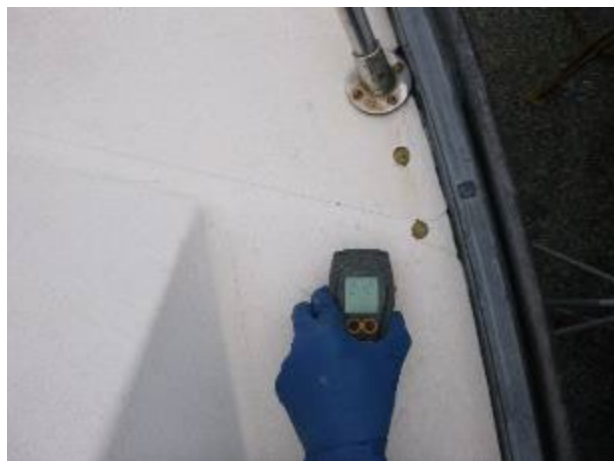
Elevated moisture in the starboard side deck. Meter reading 212.

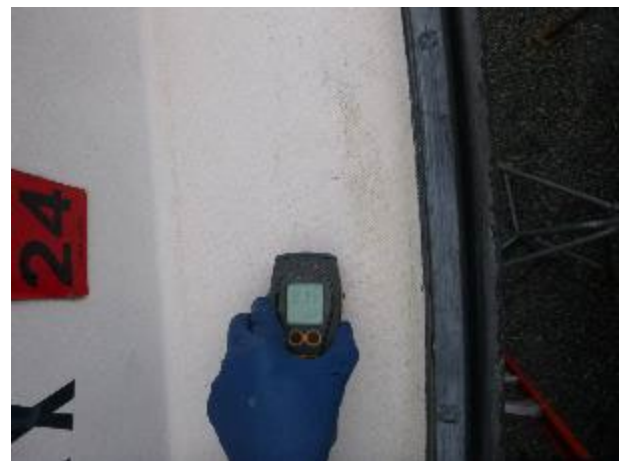
Elevated moisture in the starboard side deck. Meter reading 215.

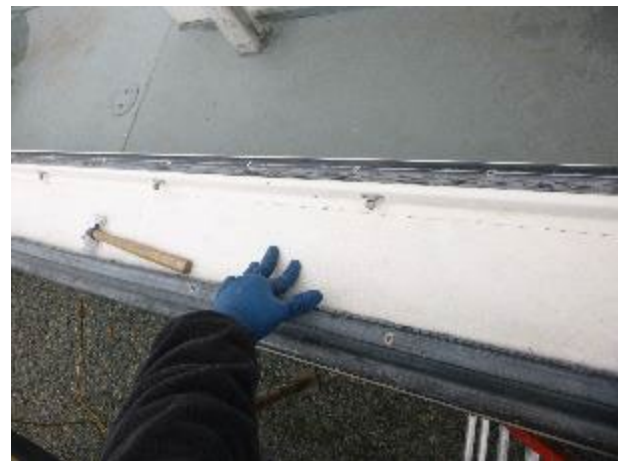
**Delamination in the starboard cockpit
coaming top.**

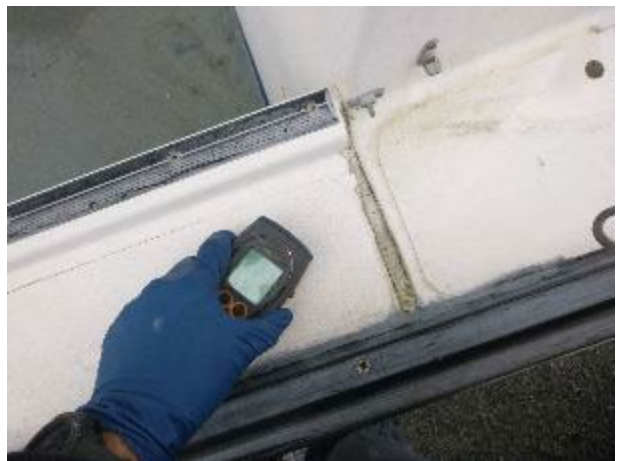
**Elevated moisture in the starboard coaming
top. Meter reading 287.**

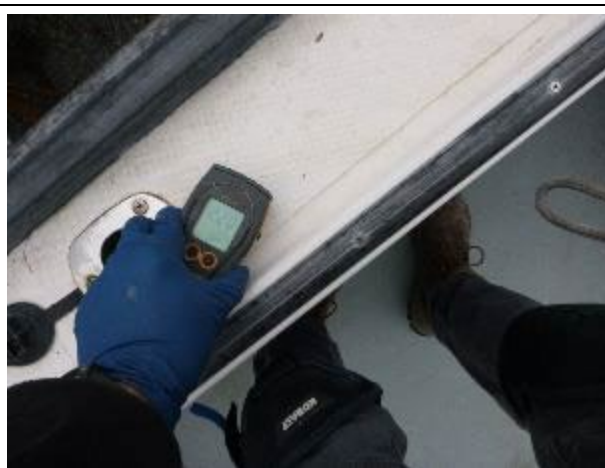
Elevated moisture in the starboard coaming top. Meter reading 220.

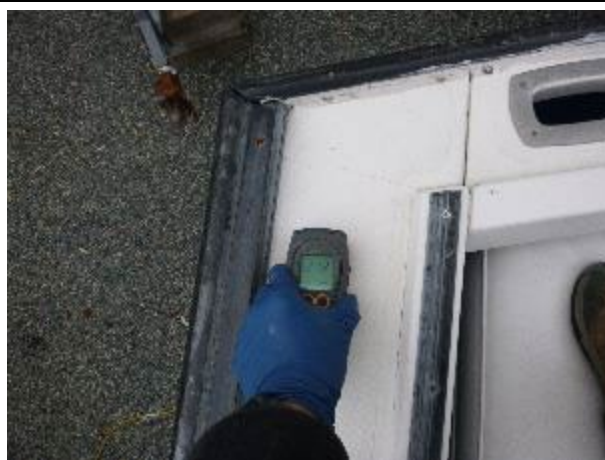
Elevated moisture in the starboard coaming top. Meter reading 210.

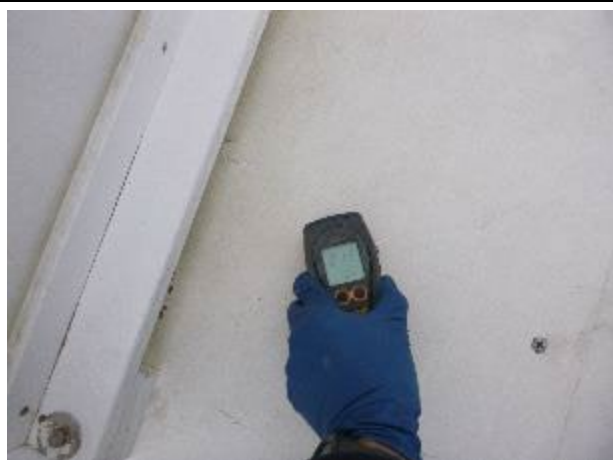
Elevated moisture in the hardtop, starboard forward. Meter reading 207.

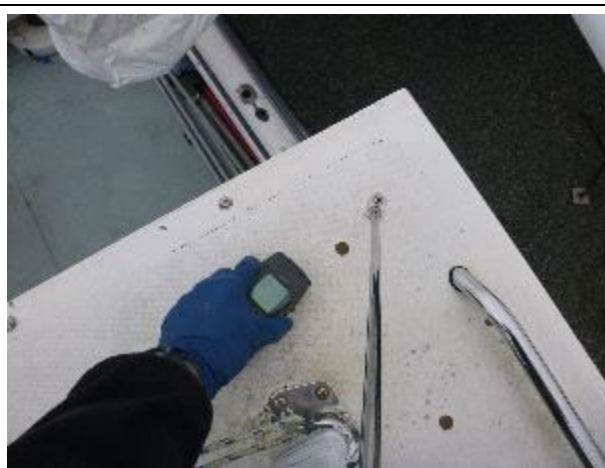
Poorly filled old fastener holes in the hardtop below the course board structure.

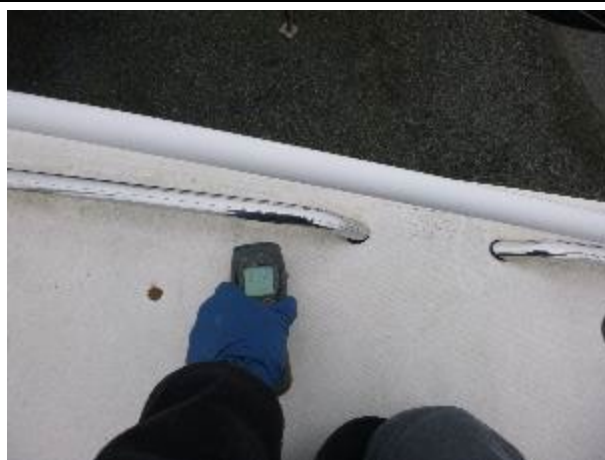
Elevated moisture in the hardtop, aft. Meter reading 210.

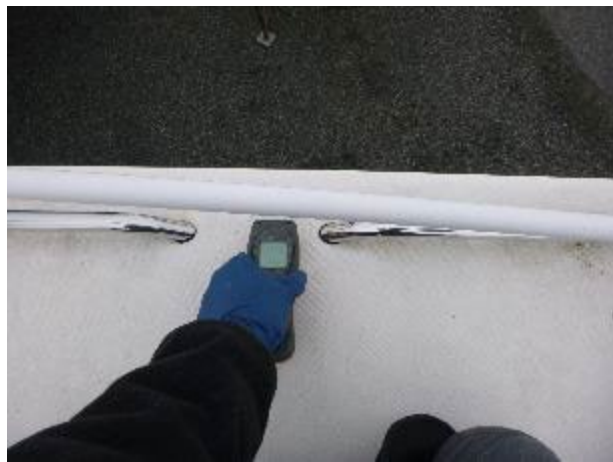
Elevated moisture in the hard top to port. Meter reading 202.

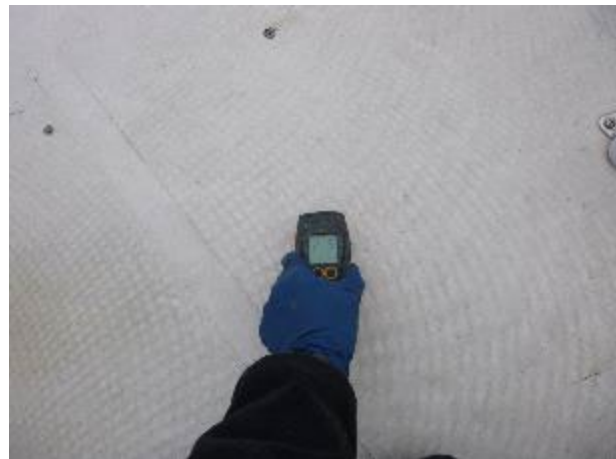
**Elevated moisture in the hardtop. Meter
reading 207.**

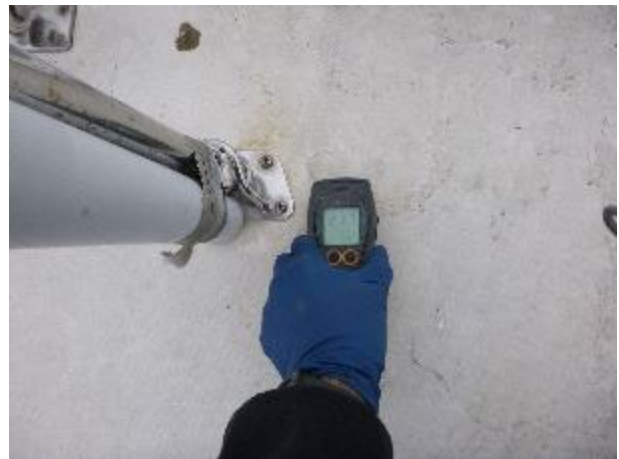
**Elevated moisture in the hardtop. Meter
reading 207.**

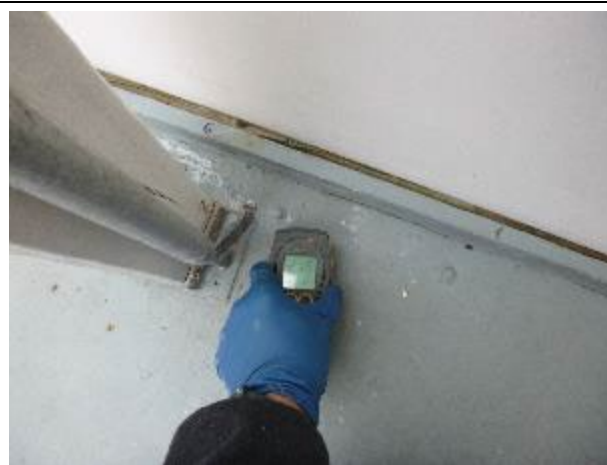
Elevated moisture in the cabinsole, forward to starboard. Meter reading 217.

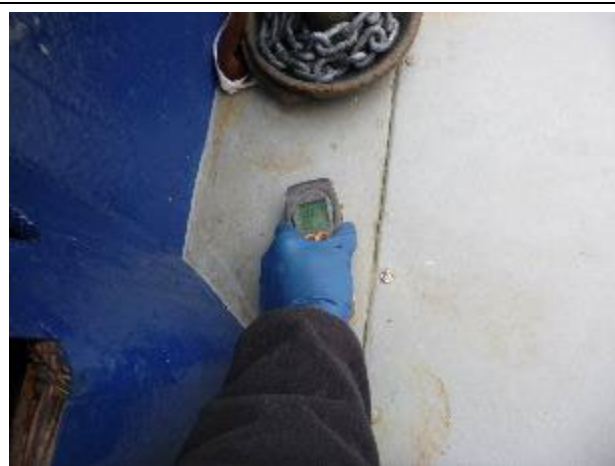
Elevated moisture in the cockpit sole to starboard of the engine box. Meter reading 207.

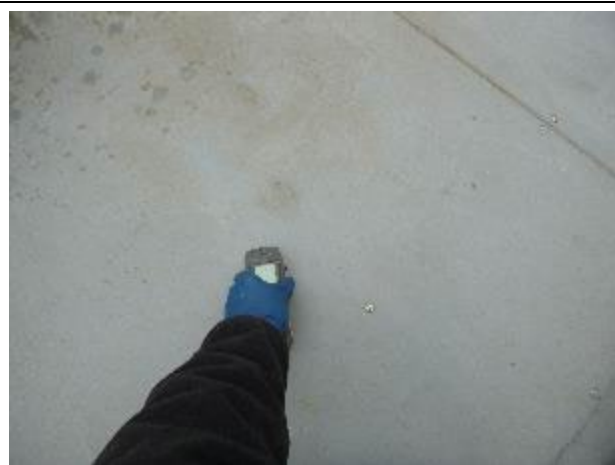
Elevated moisture in the cockpit sole to starboard. Meter reading 220.

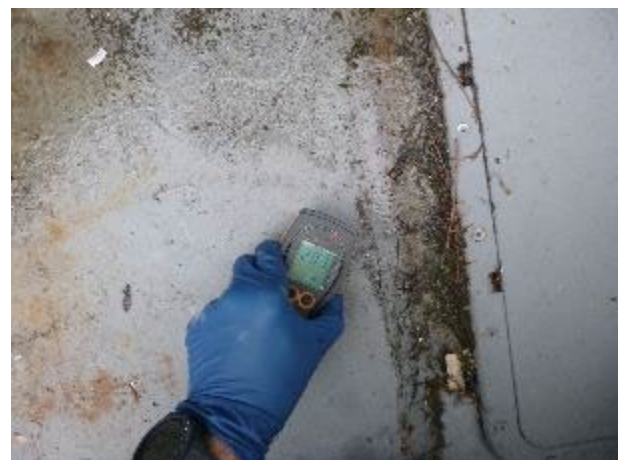
**Elevated moisture in the aft cockpit sole.
Meter reading 248.**

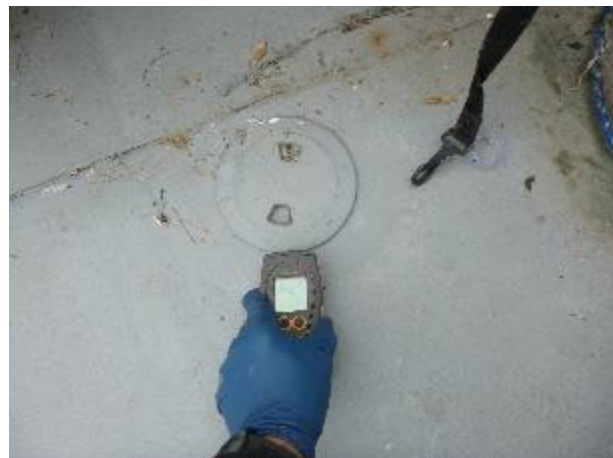
**Elevated moisture in the cockpit sole to port.
Meter reading 217.**

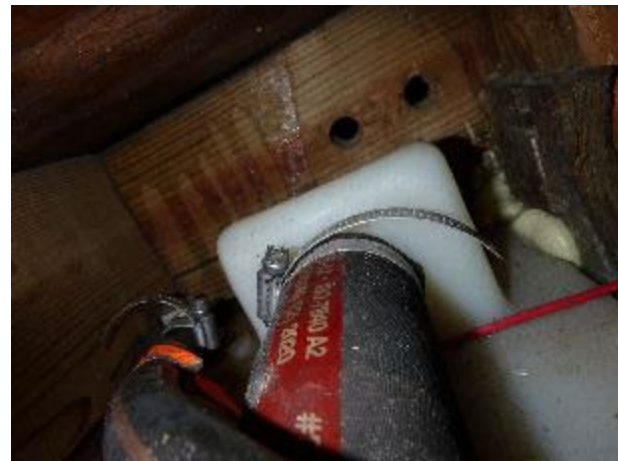
The fuel fill hose is not double hose clamped and is also loose on the deck fill spud. The fuel vent fitting is loose in the hull.

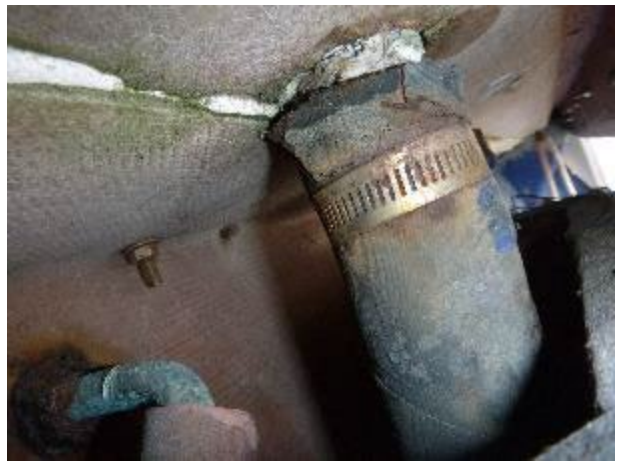
The fuel fill hose is not double hose clamped at the tank connection.

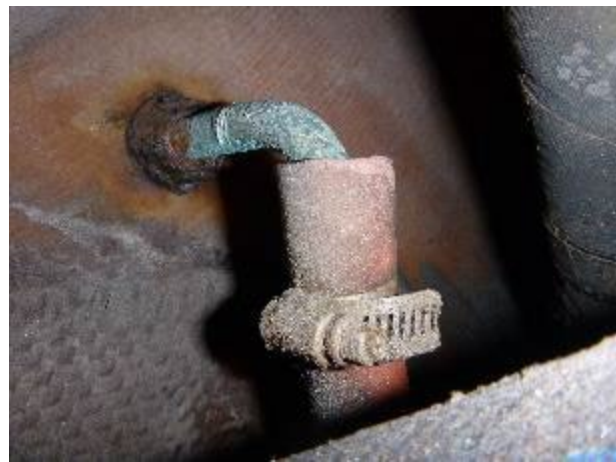
The fuel fill hose for the removed port fuel tank is deteriorated.

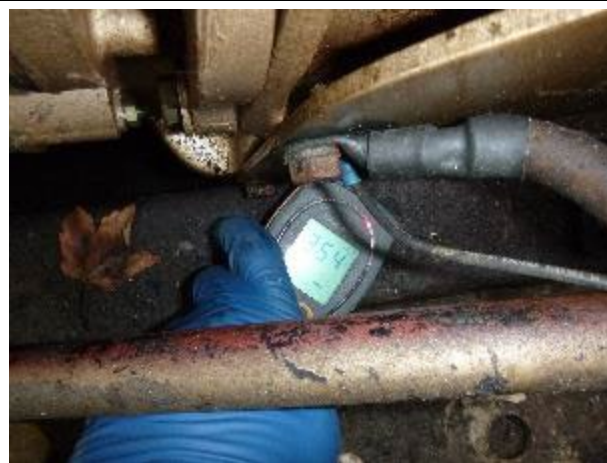
**Elevated moisture in the port engine bed.
Meter reading 202.**

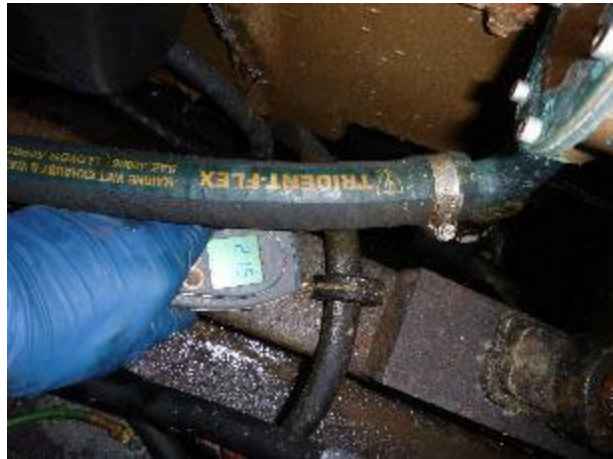
**Elevated moisture in the port engine bed.
Meter reading 354.**

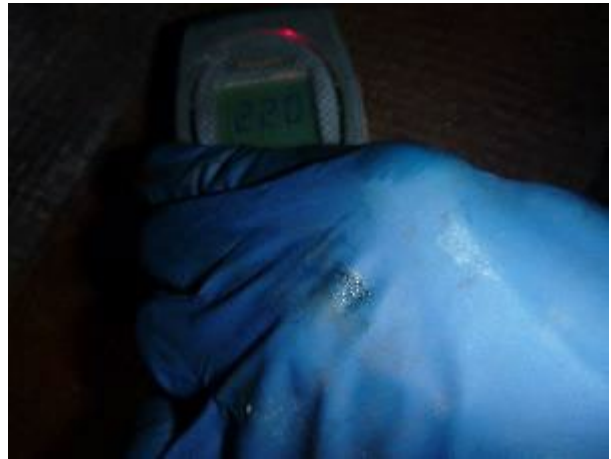
Elevated moisture in the starboard engine bed. Meter reading 215.

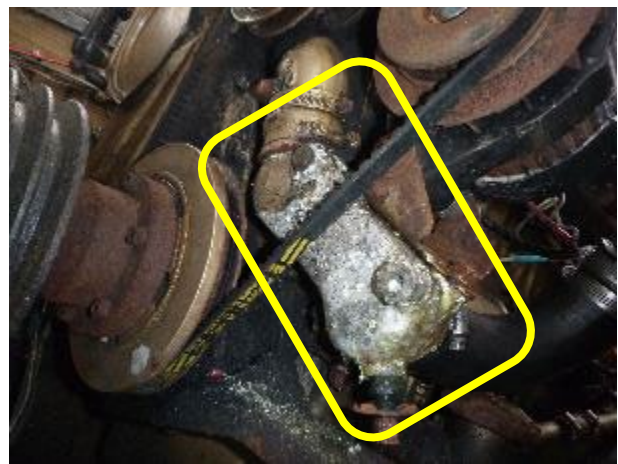
Signs of an oil leak near the forward crank shaft seal.

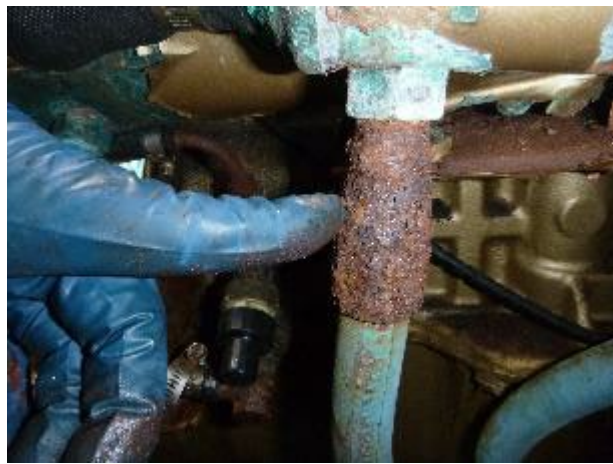
Rust and corrosion at the oil cooler to starboard.

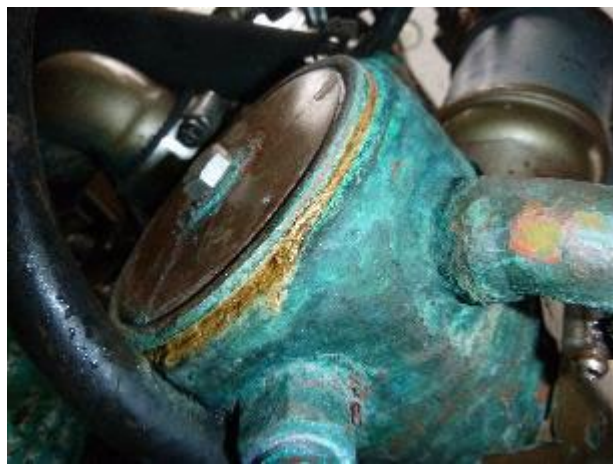
Steering hose connections rusted to starboard of the engine.

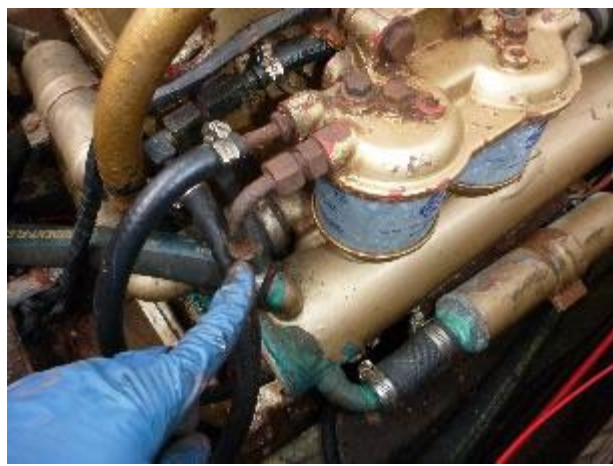
Engine heat exchanger corrosion.

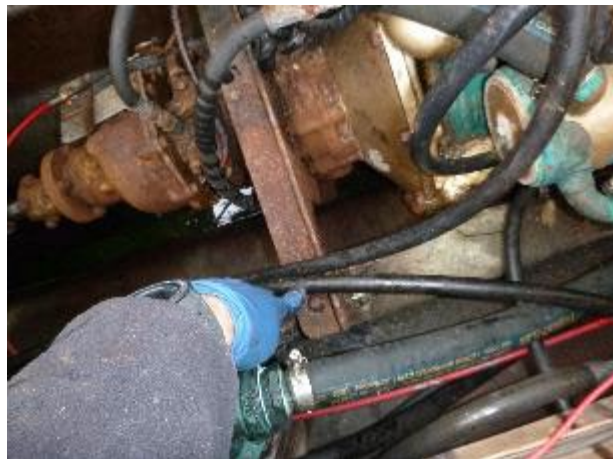
Closeup of the previous photo.

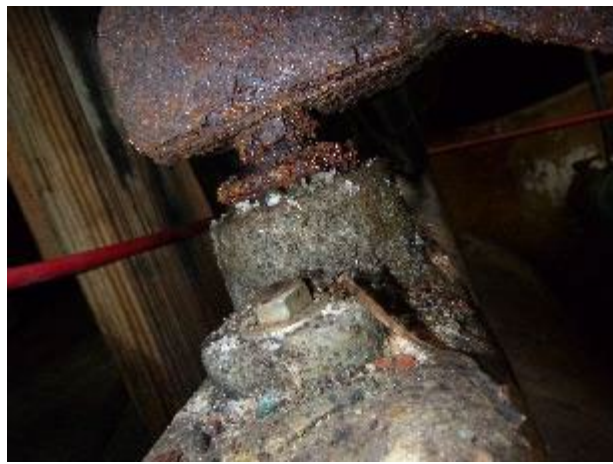
Air intake screen rusted through.

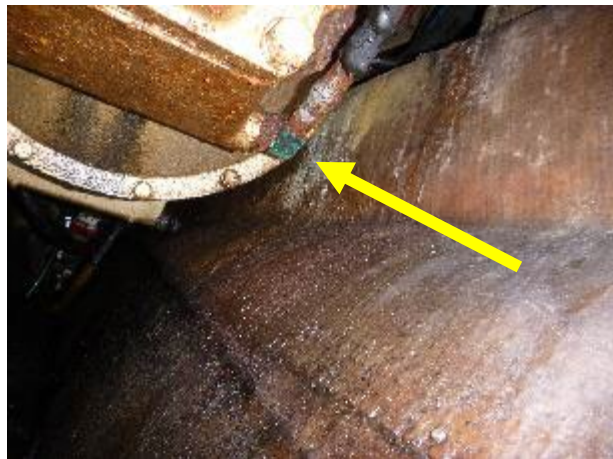
Antifreeze dripping of the port aft engine mount from a turbo leak.

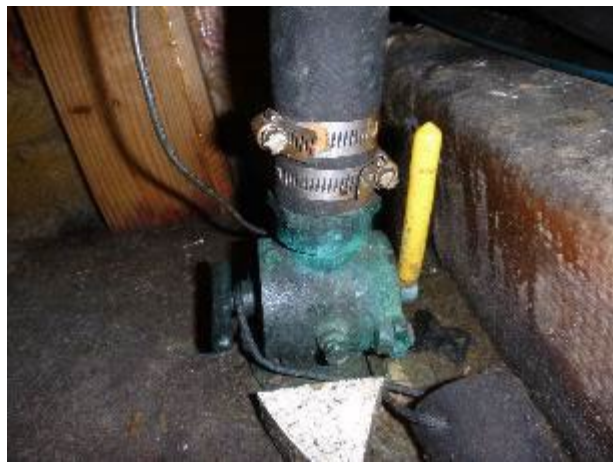
Then engine raw water strainer is missing its lower strap.

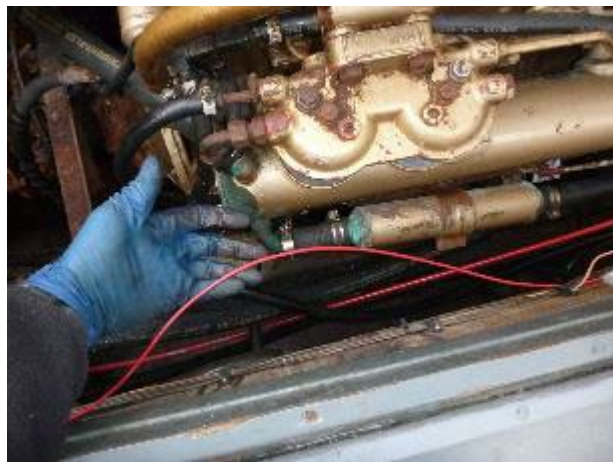
The stuffing box hose clamps are rusted, and the water injection hose clamp is broken.

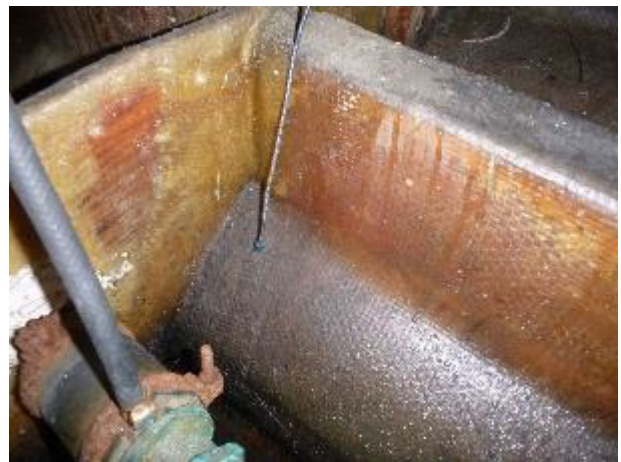
The positive wire for the fuel tank sender is not properly secured.

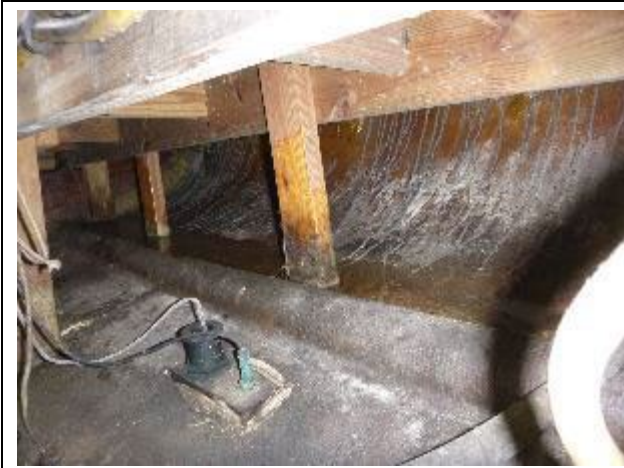
Abandoned ground wire in the port aft engine room bilge.

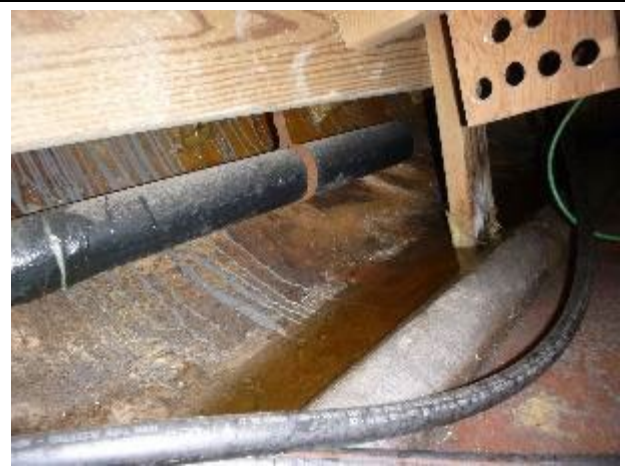
Standing water outboard of the port bilge stringer.
