DEXTER A. HOLADAY II
Marine Surveyor

PHOTO REPORT

Vessel: EDDIE MAXWELL 1988 28' Nauset Marine lobster style committee boat

Date of Inspection: 31 January 2024

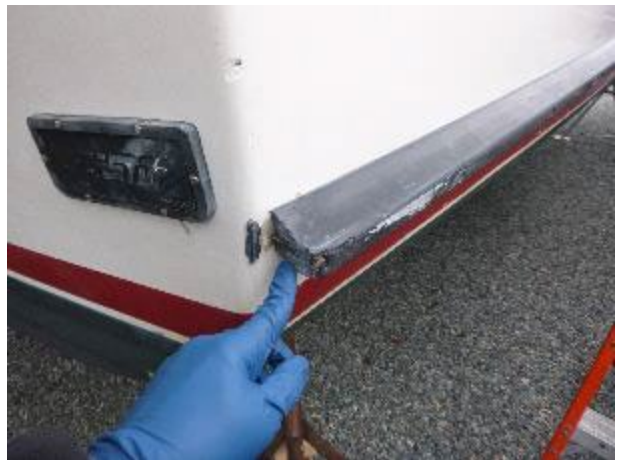
Starboard aft spray rail broken.

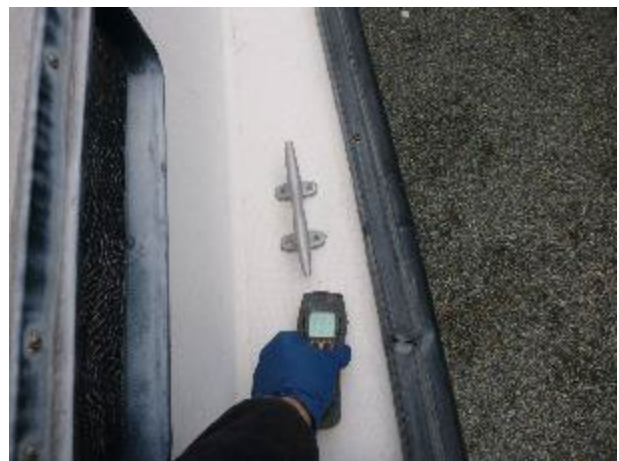
Elevated moisture in the port side deck. Meter reading 207.

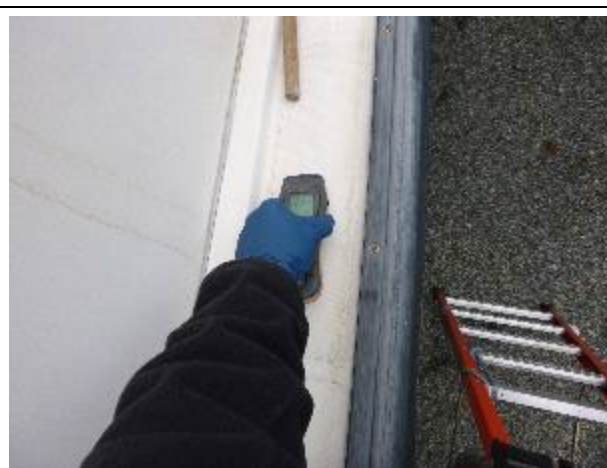
**Elevated moisture in the port side deck.
Meter reading 207.**

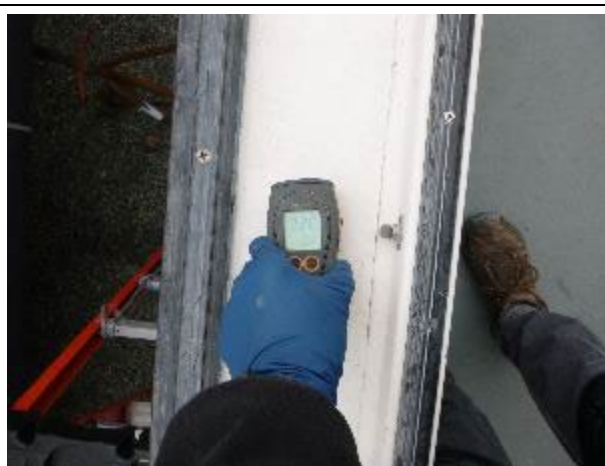
Elevated moisture in the starboard coaming top. Meter reading 220.

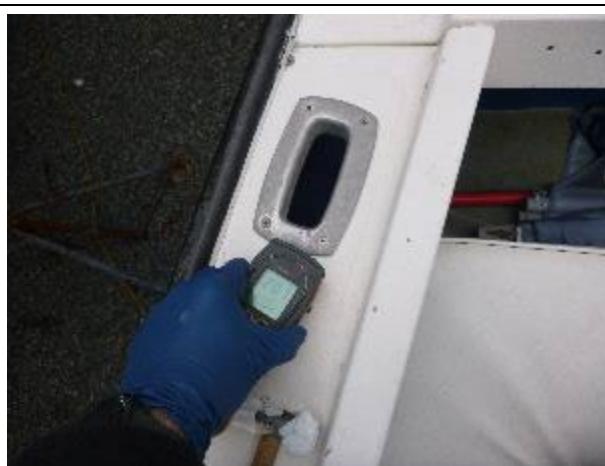
Elevated moisture in the starboard aft coaming top. Meter reading 229.

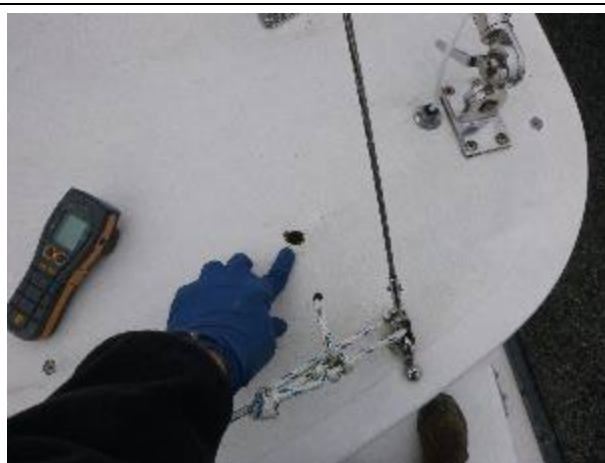
Elevated moisture in the starboard aft coaming top. Meter reading 202.

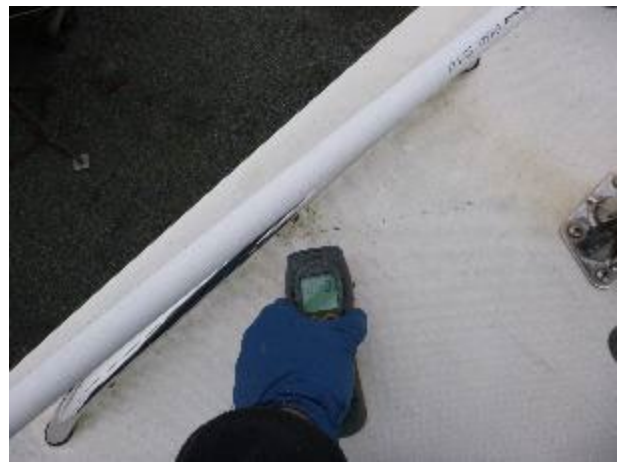
**Elevated moisture in the hardtop to port.
Meter reading 248.**

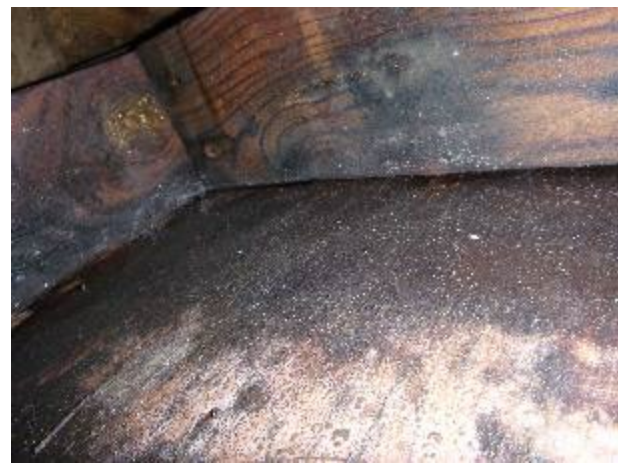
Cockpit sole plywood and structure deteriorated and wet aft of the starboard fuel tank.

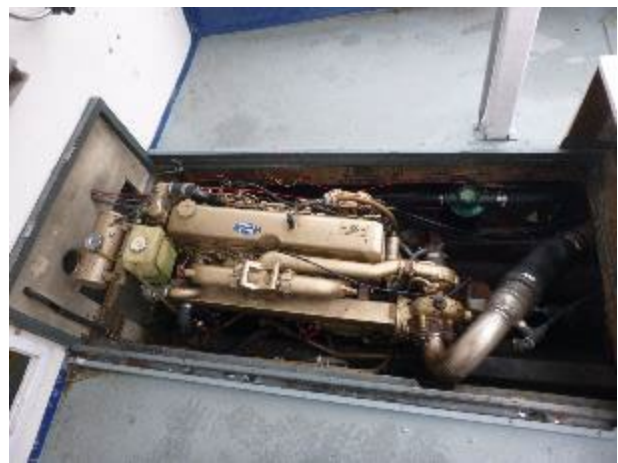
Cockpit sole plywood wet and starting to deteriorate aft.

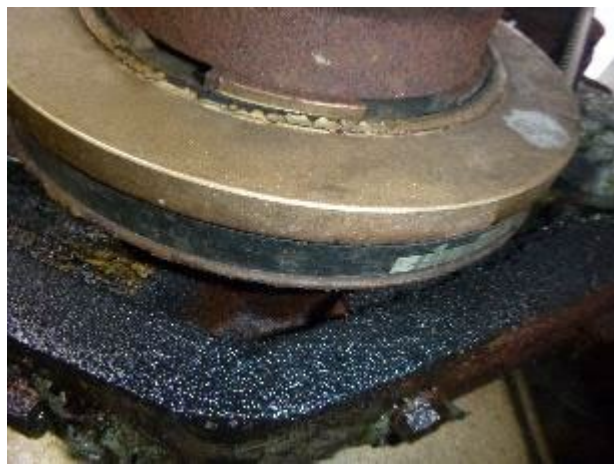
The port forward engine mount is deteriorated.

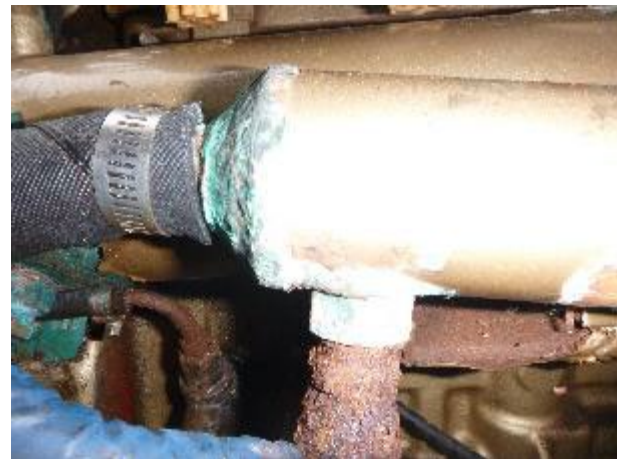
Rust and corrosion at the oil cooler to starboard.

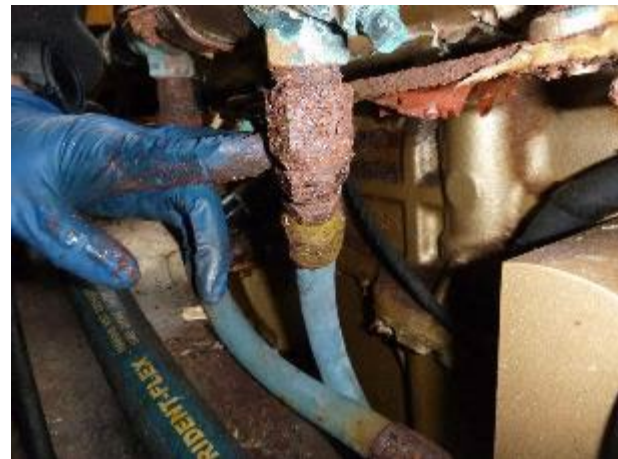
Rust and corrosion at the oil cooler to starboard.
